# Access Compliance Report

## Public Rights-of-Way

### (Curb Ramps)

Intersection ID: 7635	Main Street: PHEASANT_GLEN_RD	Cross Street: QUAIL_ST	Location: SE
ADA ID: 87E49B950D1D	Ramp Type: PerpDiag	Initial Pass/Fail: Fail	Overall Compliance: No
Codes/Mitigation Info/Possible Solution		Field Measurements/Component Compliance

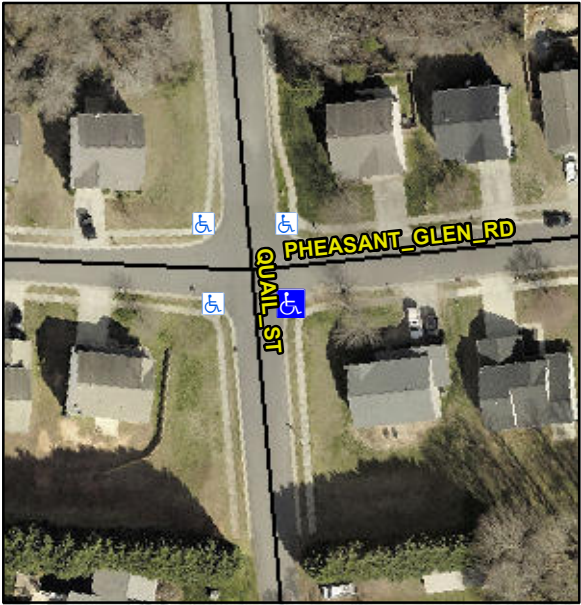
Possible Solutions:	Compliance	Description	Data	Compliance	Description	Data
	Remove & Replace Curb Ramp With Two New Directional Ramps or Equivalent.	N/A	Ramp Length (in)	47.5	No	Ramp Slope (%)	11.0
<p>Surveyor Notes:</p> <p>N/A</p> <p>PROW/ADA:</p> <p>Not Found, R304.5.1, R304.2.2, R304.5.3</p>		No	Ramp Width (in)	43.5	No	Ramp XSlope (%)	12.5
		N/A	Flare Type LT	N/A	N/A	Flare Type RT	N/A
		N/A	Flare Slope LT (%)	N/A	N/A	Flare Slope RT (%)	N/A
		N/A	Flare Traversable LT?	N/A	N/A	Flare Traversable RT?	N/A
		N/A	Landing Length (in)	N/A	N/A	DWS Provided?	N/A
		N/A	Landing Width (in)	N/A	N/A	DWS Contrast?	N/A
		N/A	Landing Slope (%)	N/A	N/A	DWS Length (in)	N/A
		N/A	Landing X Slope (%)	N/A	N/A	DWS Full Width?	N/A
		N/A	Landing Curb? (Y/N)	N/A	N/A	DWS Offset (in)	N/A
		N/A	Shared Landing?	N/A			
		N/A	Gutter Ponding?	N/A	N/A	Gutter Slope (%)	N/A
		N/A	Gutter Lip Ht (in)	N/A	N/A	Gutter X Slope (%)	N/A
		N/A	Painted X Walk1?	No	N/A	Painted X Walk2?	No

X Walk 1 Direction	To N		X Walk 2 Direction	To W
		N/A	X Walk 1 Width (in)	N/A	N/A	X Walk 2 Width (in)	N/A
			X Walk 1 Slope (%)	5.7		X Walk 2 Slope (%)	3.4
			X Walk 1 X Slope (%)	4.0		X Walk 2 X Slope (%)	10.7
		N/A	Ramp inside XWalk1?	N/A	N/A	Ramp inside XWalk2?	N/A
			Road Slope (%)	9.6	N/A	Clear Space?	N/A
			Road X Slope (%)	3.0	N/A	Clear Space to XWalk (in)	N/A
		N/A	Any Obstructions?	N/A	N/A	Storm Grate/Utility Hazard?	N/A
			Obstruction Type			Storm Grate/Utility Type	
				N/A			N/A
					Yes	Surface Condition? (G/P)	Good
