Access Compliance Report

Public Rights-of-Way

(Curb Ramps)

Intersection ID: 23104	Main Street: PENSFORD_LN	Cross Street: LYNBRIDGE_DR	Location: NE
ADA ID: 87E62A2C9FBC	Ramp Type: Perp	Initial Pass/Fail: Fail	Overall Compliance: No
Severity Score: 33.75			
Codes/Mitigation Info/Possible Solution		Field Measurements/Component Compliance

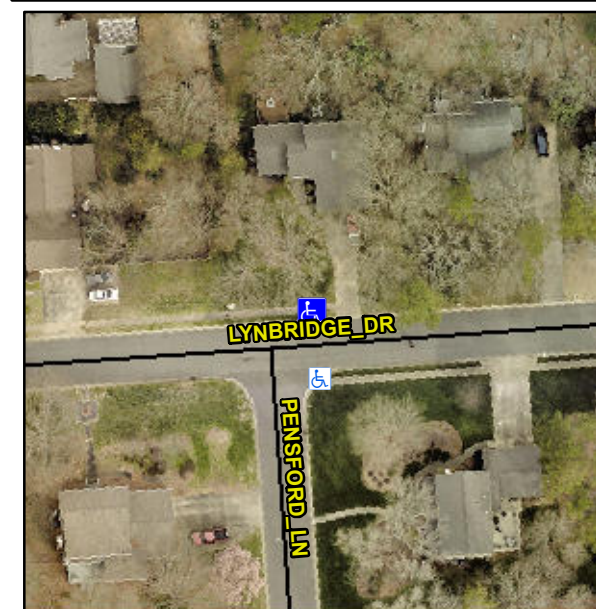
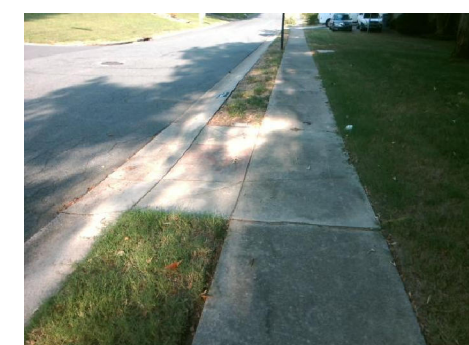
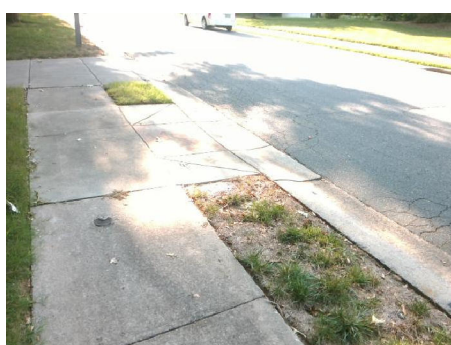
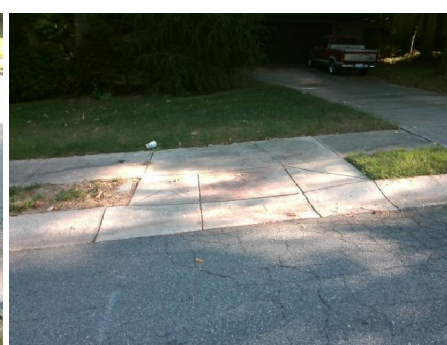
Not Found, R304.5.1, R304.5.3

Compliance	Description	Data	Compliance	Description	Data
N/A	Ramp Length (in)	34.0	Yes	Ramp Slope (%)	5.5
No	Ramp Width (in)	46.5	No	Ramp XSlope (%)	7.3
N/A	Flare Type LT	N/A	N/A	Flare Type RT	N/A
N/A	Flare Slope LT (%)	N/A	N/A	Flare Slope RT (%)	N/A
N/A	Flare Traversable LT?	N/A	N/A	Flare Traversable RT?	N/A
N/A	Landing Length (in)	N/A	N/A	DWS Provided?	N/A
N/A	Landing Width (in)	N/A	N/A	DWS Contrast?	N/A
N/A	Landing Slope (%)	N/A	N/A	DWS Length (in)	N/A
N/A	Landing X Slope (%)	N/A	N/A	DWS Full Width?	N/A
N/A	Landing Curb? (Y/N)	N/A	N/A	DWS Offset (in)	N/A
N/A	Shared Landing?	N/A			
N/A	Gutter Ponding?	N/A	N/A	Gutter Slope (%)	N/A
N/A	Gutter Lip Ht (in)	N/A	N/A	Gutter X Slope (%)	N/A
N/A	Painted X Walk1?	No	N/A	Painted X Walk2?	N/A
	X Walk 1 Direction	To S		X Walk 2 Direction	N/A
N/A	X Walk 1 Width (in)	N/A	N/A	X Walk 2 Width (in)	N/A
	X Walk 1 Slope (%)	4.9		X Walk 2 Slope (%)	N/A
	X Walk 1 X Slope (%)	6.5		X Walk 2 X Slope (%)	N/A

N/A	Ramp inside XWalk1?	N/A	N/A	Ramp inside XWalk2?	N/A
	Road Slope (%)	N/A	N/A	Clear Space?	N/A
	Road X Slope (%)	N/A	N/A	Clear Space to XWalk (in)	N/A
N/A	Any Obstructions?	N/A	N/A	Storm Grate/Utility Hazard?	N/A
	Obstruction Type			Storm Grate/Utility Type	
		N/A			N/A
			Yes	Surface Condition? (G/P)	Good

Possible Solutions:

Remove & Replace Entire Ramp.
