## **Access Compliance Report Public Rights-of-Way** (Curb Ramps)

Intersection ID: 10079 Main Street: GASTON\_ST Cross Street: TUCKASEEGEE\_RD Location: Ε ADA ID: 87EBC79C37E4 Ramp Type: Directional1 Initial Pass/Fail: Fail **Overall Compliance: No Severity Score:** 1.25

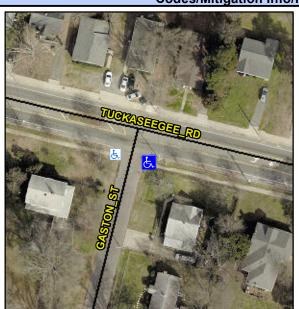
Field Measurements/Component Compliance						
Compliance Description		Data	Comp	liance Description	Data	
N/A	Ramp Length (in)	87.0	N/A	Grade Break?	N/A	
Yes	Ramp Width (in)	48.0	N/A	Grade Break Slope (%)	0.0	
Yes	Ramp Slope (%)	6.8	N/A	Grade Break XSlope (%)	0.0	
No	Ramp XSlope (%)	4.1				
N/A	Flare Type LT	N/A	N/A	Flare Type RT	N/A	
N/A	Flare Slope LT (%)	N/A	N/A	Flare Slope RT (%)	0.0	
N/A	Flare Traversable LT?	N/A	N/A	Flare Traversable RT?	N/A	
N/A	Landing Length (in)	0.0	N/A	DWS Provided?	N/A	
N/A	Landing Width (in)	0.0	N/A	DWS Contrast?	N/A	
N/A	Landing Slope (%)	0.0	N/A	DWS Length (in)	N/A	
N/A	Landing X Slope (%)	0.0	N/A	DWS Full Width?	N/A	
N/A	Landing Curb? (Y/N)	N/A	N/A	DWS Offset LT (in)	N/A	
N/A	Shared Landing?	N/A	N/A	DWS Offset RT (in)	N/A	
N/A	Gutter Ponding?	0.0	N/A	Gutter Slope (%)	N/A	
N/A	Gutter Lip Ht (in)	0.5	N/A	Gutter X Slope (%)	N/A	
N/A	Painted X Walk1?	No		Road Slope (%)	0.5	
	X Walk 1 Direction	To W		Road X Slope (%)	0.7

X Walk 1 Width (in)	N/A		Clear Space?	N/A	
	X Walk 1 Slope (%)	0.5	N/A	Clear Space to XWalk (in)	N/A	
	X Walk 1 X Slope (%)	0.7	N/A	Storm Grate/Utility Hazard?	N/A	
N/A	Ramp inside XWalk1?	N/A		Storm Grate/Utility Type		
N/A	Any Obstructions?	N/A			N/A	
	Obstruction Type		Yes	Surface Condition? (G/P)	Good	
		N/A	N/A	Curb Slope (%)	2.6

i ossible odlation			
Possible Solutions:	<u>c</u>		
Remove & Replace Entire Ramp.			
	Υ		
	Υ		
	N		
	N		
	N		
Surveyor Notes:	N		
N/A	N		
	N		
	N		
	N		
PROW/ADA:	N		
R304.5.3	N		
	N		
	N		
	N
