ADA ID: 87EBCB54E206

Access Compliance Report Public Rights-of-Way (Curb Ramps)

Cross Street: SANDERS AV Location: Intersection ID: 9358 Main Street: BEATTIES FORD RD Ν Ramp Type: Perp Initial Pass/Fail: Fail **Overall Compliance: No** 1.25

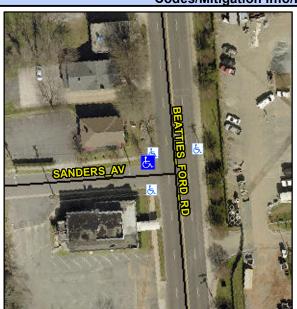
Possible Solutions:	Comp	pliance Description	Data	Compl	iance	Description
Remove & Replace Entire Ramp.	N/A	Ramp Length (in)	62.0	Yes	Ramp	Slope (%)
	Yes	Ramp Width (in)	65.0	No		XSlope (%)
	N/A	Flare Type LT	N/A	N/A	Flare	Type RT
	N/A	Flare Slope LT (%)	N/A	N/A	Flare	Slope RT (%)
	N/A	Flare Traversable LT?	N/A	N/A	Flare	Traversable R
	N/A	Landing Length (in)	N/A	N/A	DWS	Provided?
Surveyor Notes:	N/A	Landing Width (in)	N/A	N/A	DWS	Contrast?
N/A	N/A	Landing Slope (%)	N/A	N/A	DWS	Length (in)
	N/A	Landing X Slope (%)	N/A	N/A	DWS	Full Width?
	N/A	Landing Curb? (Y/N)	N/A	N/A	DWS	Offset (in)
	N/A	Shared Landing?	N/A			
PROW/ADA:	N/A	Gutter Ponding?	N/A	N/A	Gutte	r Slope (%)
R304.5.3	N/A	Gutter Lip Ht (in)	N/A	N/A	Gutte	r X Slope (%)
	N/A	Painted X Walk1?	No	N/A	Painte	ed X Walk2?
		X Walk 1 Direction	To S		X Wa	lk 2 Direction
	N/A	X Walk 1 Width (in)	N/A	N/A	X Wa	lk 2 Width (in)
		X Walk 1 Slope (%)	3.3		X Wa	lk 2 Slope (%)

X Walk 1 X Slope (%)	4.3		X Wa	lk 2 X Slope (%
	N/A	Ramp inside XWalk1?	N/A	N/A	Ramp	inside XWalk2
		Road Slope (%)	N/A	N/A	Clear	Space?
		Road X Slope (%)	N/A	N/A	Clear	Space to XWa
	N/A	Any Obstructions?	N/A	N/A	Storm	Grate/Utility H

Total Cost:

1850.00
