# Access Compliance Report

## Public Rights-of-Way

### (Curb Ramps)

Intersection ID: 45174	Main Street: LINDEN_TREE_LN	Cross Street: SOCIETY_ST	Location: NW
ADA ID: 87F7AFA0C15D	Ramp Type: Perp	Initial Pass/Fail: Fail	Overall Compliance: No
Severity Score: 12.5			
Codes/Mitigation Info/Possible Solution		Field Measurements/Component Compliance

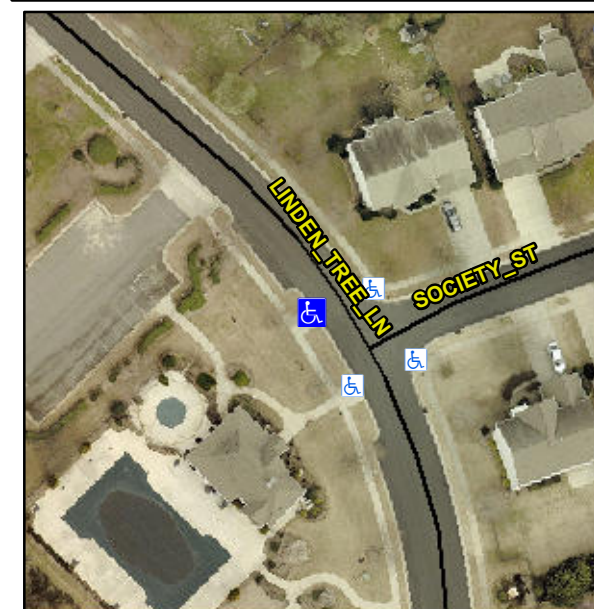
**Not Found, R304.2.2**

Compliance	Description	Data	Compliance	Description	Data
N/A	Ramp Length (in)	122.0	No	Ramp Slope (%)	9.4
Yes	Ramp Width (in)	60.0	Yes	Ramp XSlope (%)	0.6
N/A	Flare Type LT	N/A	N/A	Flare Type RT	N/A
N/A	Flare Slope LT (%)	N/A	N/A	Flare Slope RT (%)	N/A
N/A	Flare Traversable LT?	N/A	N/A	Flare Traversable RT?	N/A
N/A	Landing Length (in)	N/A	N/A	DWS Provided?	N/A
N/A	Landing Width (in)	N/A	N/A	DWS Contrast?	N/A
N/A	Landing Slope (%)	N/A	N/A	DWS Length (in)	N/A
N/A	Landing X Slope (%)	N/A	N/A	DWS Full Width?	N/A
N/A	Landing Curb? (Y/N)	N/A	N/A	DWS Offset (in)	N/A
N/A	Shared Landing?	N/A			
N/A	Gutter Ponding?	N/A	N/A	Gutter Slope (%)	N/A
N/A	Gutter Lip Ht (in)	N/A	N/A	Gutter X Slope (%)	N/A
N/A	Painted X Walk1?	No	N/A	Painted X Walk2?	N/A
	X Walk 1 Direction	To NE		X Walk 2 Direction	N/A
N/A	X Walk 1 Width (in)	N/A	N/A	X Walk 2 Width (in)	N/A
	X Walk 1 Slope (%)	2.3		X Walk 2 Slope (%)	N/A
	X Walk 1 X Slope (%)	2.4		X Walk 2 X Slope (%)	N/A

N/A	Ramp inside XWalk1?	N/A	N/A	Ramp inside XWalk2?	N/A
	Road Slope (%)	N/A	N/A	Clear Space?	N/A
	Road X Slope (%)	N/A	N/A	Clear Space to XWalk (in)	N/A
N/A	Any Obstructions?	N/A	N/A	Storm Grate/Utility Hazard?	N/A
	Obstruction Type			Storm Grate/Utility Type	
		N/A			N/A
			Yes	Surface Condition? (G/P)	Good

**Remove & Replace Entire Ramp.**

Total Cost: \$ 1850.00
