Access Compliance Report Public Rights-of-Way (Curb Ramps)

Intersection ID: 10958 Main Street: CAMP_GREENE_ST Cross Street: TUCKASEEGEE_RD Location: SW

ADA ID: 87FD8975AECC Ramp Type: Perp Initial Pass/Fail: Fail Overall Compliance: No Severity Score: 13.75

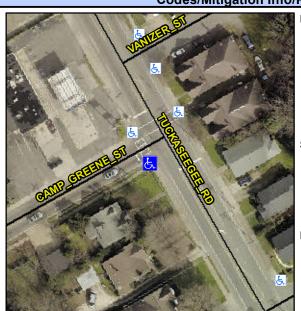
Field Measurements/Component Compliance						
Compliance Description		Data	Comp	liance Description	Data	
N/A	Ramp Length (in)	75.0	No	Ramp Slope (%)	8.7	
Yes	Ramp Width (in)	48.0	No	Ramp XSlope (%)	4.5	
N/A	Flare Type LT	N/A	N/A	Flare Type RT	N/A	
N/A	Flare Slope LT (%)	N/A	N/A	Flare Slope RT (%)	N/A	
N/A	Flare Traversable LT?	N/A	N/A	Flare Traversable RT?	N/A	
N/A	Landing Length (in)	N/A	N/A	DWS Provided?	N/A	
N/A	Landing Width (in)	N/A	N/A	DWS Contrast?	N/A	
N/A	Landing Slope (%)	N/A	N/A	DWS Length (in)	N/A	
N/A	Landing X Slope (%)	N/A	N/A	DWS Full Width?	N/A	
N/A	Landing Curb? (Y/N)	N/A	N/A	DWS Offset (in)	N/A	
N/A	Shared Landing?	N/A				
N/A	Gutter Ponding?	N/A	N/A	Gutter Slope (%)	N/A	
N/A	Gutter Lip Ht (in)	N/A	N/A	Gutter X Slope (%)	N/A	
N/A	Painted X Walk1?	Yes	N/A	Painted X Walk2?	N/A	
	X Walk 1 Direction	To N		X Walk 2 Direction	N/A	
N/A	X Walk 1 Width (in)	113.0	N/A	X Walk 2 Width (in)	N/A	
	X Walk 1 Slope (%)	8.3		X Walk 2 Slope (%)	N/A

X Walk 1 X Slope (%)	1.8		X Walk 2 X Slope (%)	N/A	
N/A	Ramp inside XWalk1?	Yes	N/A	Ramp inside XWalk2?	N/A	
	Road Slope (%)	N/A	N/A	Clear Space?	N/A	
	Road X Slope (%)	N/A	N/A	Clear Space to XWalk (in)	N/A	
N/A	Any Obstructions?	N/A	N/A	Storm Grate/Utility Hazard?	N/A	
	Obstruction Type			Storm Grate/Utility Type		
		N/A			N/A	
			Yes	Surface Condition? (G/P)	Good

i ossible odlation	
Possible Solutions:	9
Remove & Replace Entire Ramp.	1
	•
	N
	1
	ı
	ı
Surveyor Notes:	ı
N/A	ı
	ı
	ı
	ı
PROW/ADA:	ı
Not Found, R304.2.2, R304.5.3	N
	ı
	ı

Total Cost: \$ 1850.00
