Intersection ID: 21614	Main Street: RITTENHOUSE_CR	Cross Street: SARDIS_RD_NORTH	Location:	SW
ADA ID: 87FFE26D49EB	Ramp Type: PerpDiag	Initial Pass/Fail: Fail	Overall Compliance: No	Severity Score: 26.25

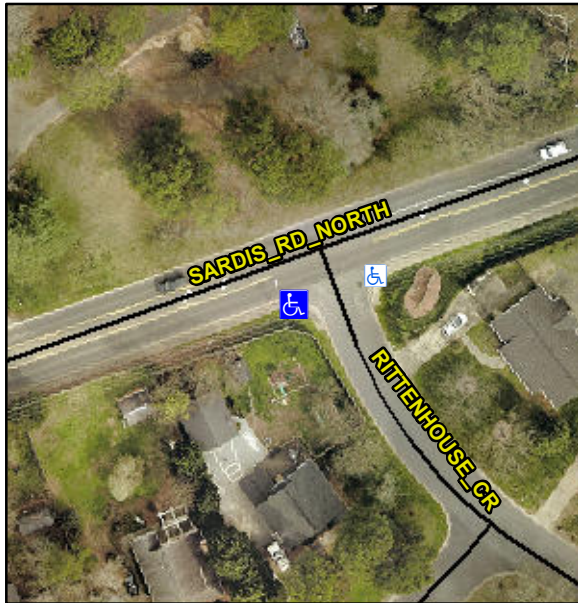
Compliance	Description	Data	Compliance	Description	Data
N/A	Ramp Length (in)	48.0	No	Ramp Slope (%)	12.9
Yes	Ramp Width (in)	48.0	No	Ramp XSlope (%)	3.5
N/A	Flare Type LT	N/A	N/A	Flare Type RT	N/A
N/A	Flare Slope LT (%)	N/A	N/A	Flare Slope RT (%)	N/A
N/A	Flare Traversable LT?	N/A	N/A	Flare Traversable RT?	N/A
N/A	Landing Length (in)	N/A	N/A	DWS Provided?	N/A
N/A	Landing Width (in)	N/A	N/A	DWS Contrast?	N/A
N/A	Landing Slope (%)	N/A	N/A	DWS Length (in)	N/A
N/A	Landing X Slope (%)	N/A	N/A	DWS Full Width?	N/A
N/A	Landing Curb? (Y/N)	N/A	N/A	DWS Offset (in)	N/A
N/A	Shared Landing?	N/A			
N/A	Gutter Ponding?	N/A	N/A	Gutter Slope (%)	N/A
N/A	Gutter Lip Ht (in)	N/A	N/A	Gutter X Slope (%)	N/A
N/A	Painted X Walk1?	No	N/A	Painted X Walk2?	No
	X Walk 1 Direction	To E		X Walk 2 Direction	To N
N/A	X Walk 1 Width (in)	N/A	N/A	X Walk 2 Width (in)	N/A
	X Walk 1 Slope (%)	3.5		X Walk 2 Slope (%)	2.6
	X Walk 1 X Slope (%)	2.8		X Walk 2 X Slope (%)	3.3

N/A	Ramp inside XWalk1?	N/A	N/A	Ramp inside XWalk2?	N/A
	Road Slope (%)	1.3	N/A	Clear Space?	N/A
	Road X Slope (%)	5.5	N/A	Clear Space to XWalk (in)	N/A
N/A	Any Obstructions?	N/A	N/A	Storm Grate/Utility Hazard?	N/A
	Obstruction Type			Storm Grate/Utility Type	
		N/A			N/A
			Yes	Surface Condition? (G/P)	Good

Possible Solutions:

Remove & Replace Curb Ramp With Two New Directional Ramps or Equivalent.
