Intersection ID: 9237	Main Street: REDBUD_ST	Cross Street: BOOKER_AV	Location:	NW
ADA ID: 8811500640D6	Ramp Type: PerpDiag	Initial Pass/Fail: Fail	Overall Compliance: No	Severity Score: 36.25

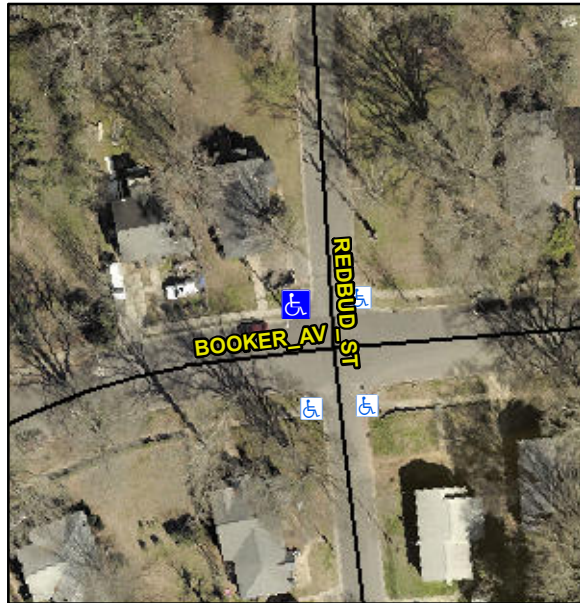
Not Found, R304.5.1, R304.5.3

Compliance	Description	Data	Compliance	Description	Data
N/A	Ramp Length (in)	51.5	Yes	Ramp Slope (%)	5.3
No	Ramp Width (in)	30.0	No	Ramp XSlope (%)	2.5
N/A	Flare Type LT	N/A	N/A	Flare Type RT	N/A
N/A	Flare Slope LT (%)	N/A	N/A	Flare Slope RT (%)	N/A
N/A	Flare Traversable LT?	N/A	N/A	Flare Traversable RT?	N/A
N/A	Landing Length (in)	N/A	N/A	DWS Provided?	N/A
N/A	Landing Width (in)	N/A	N/A	DWS Contrast?	N/A
N/A	Landing Slope (%)	N/A	N/A	DWS Length (in)	N/A
N/A	Landing X Slope (%)	N/A	N/A	DWS Full Width?	N/A
N/A	Landing Curb? (Y/N)	N/A	N/A	DWS Offset (in)	N/A
N/A	Shared Landing?	N/A			
N/A	Gutter Ponding?	N/A	N/A	Gutter Slope (%)	N/A
N/A	Gutter Lip Ht (in)	N/A	N/A	Gutter X Slope (%)	N/A
N/A	Painted X Walk1?	No	N/A	Painted X Walk2?	No
	X Walk 1 Direction	To S		X Walk 2 Direction	To E
N/A	X Walk 1 Width (in)	N/A	N/A	X Walk 2 Width (in)	N/A
	X Walk 1 Slope (%)	4.9		X Walk 2 Slope (%)	2.1
	X Walk 1 X Slope (%)	1.5		X Walk 2 X Slope (%)	2.7

N/A	Ramp inside XWalk1?	N/A	N/A	Ramp inside XWalk2?	N/A
	Road Slope (%)	2.1	N/A	Clear Space?	N/A
	Road X Slope (%)	3.9	N/A	Clear Space to XWalk (in)	N/A
N/A	Any Obstructions?	N/A	N/A	Storm Grate/Utility Hazard?	N/A
	Obstruction Type			Storm Grate/Utility Type	
		N/A			N/A
			Yes	Surface Condition? (G/P)	Good

Remove & Replace Curb Ramp With Two New Directional Ramps or Equivalent.
