Access Compliance Report

Public Rights-of-Way

(Curb Ramps)

Intersection ID: 17140	Main Street: S_WENDOVER_RD	Cross Street: SEDGEWOOD_CR	Location: SW
ADA ID: 88193A373229	Ramp Type: PerpDiag	Initial Pass/Fail: Fail	Overall Compliance: No
Severity Score: 22.5			
Codes/Mitigation Info/Possible Solution		Field Measurements/Component Compliance

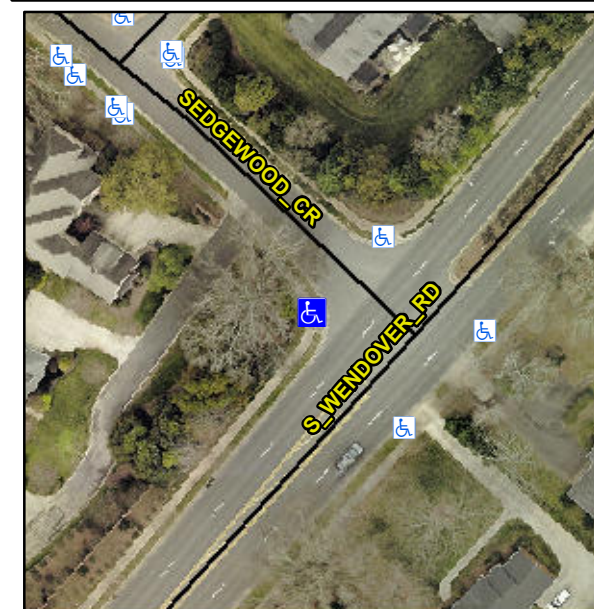
Not Found, R304.5.1, R304.2.2, R304.5.3

Compliance	Description	Data	Compliance	Description	Data
N/A	Ramp Length (in)	48.0	No	Ramp Slope (%)	11.2
No	Ramp Width (in)	43.0	No	Ramp XSlope (%)	2.6
N/A	Flare Type LT	N/A	N/A	Flare Type RT	N/A
N/A	Flare Slope LT (%)	N/A	N/A	Flare Slope RT (%)	N/A
N/A	Flare Traversable LT?	N/A	N/A	Flare Traversable RT?	N/A
N/A	Landing Length (in)	N/A	N/A	DWS Provided?	N/A
N/A	Landing Width (in)	N/A	N/A	DWS Contrast?	N/A
N/A	Landing Slope (%)	N/A	N/A	DWS Length (in)	N/A
N/A	Landing X Slope (%)	N/A	N/A	DWS Full Width?	N/A
N/A	Landing Curb? (Y/N)	N/A	N/A	DWS Offset (in)	N/A
N/A	Shared Landing?	N/A			
N/A	Gutter Ponding?	N/A	N/A	Gutter Slope (%)	N/A
N/A	Gutter Lip Ht (in)	N/A	N/A	Gutter X Slope (%)	N/A
N/A	Painted X Walk1?	No	N/A	Painted X Walk2?	No
	X Walk 1 Direction	To SE		X Walk 2 Direction	To NE
N/A	X Walk 1 Width (in)	N/A	N/A	X Walk 2 Width (in)	N/A
	X Walk 1 Slope (%)	0.3		X Walk 2 Slope (%)	3.8
	X Walk 1 X Slope (%)	1.5		X Walk 2 X Slope (%)	2.5

N/A	Ramp inside XWalk1?	N/A	N/A	Ramp inside XWalk2?	N/A
	Road Slope (%)	1.1	N/A	Clear Space?	N/A
	Road X Slope (%)	3.9	N/A	Clear Space to XWalk (in)	N/A
N/A	Any Obstructions?	N/A	N/A	Storm Grate/Utility Hazard?	N/A
	Obstruction Type			Storm Grate/Utility Type	
		N/A			N/A
			Yes	Surface Condition? (G/P)	Good

Possible Solutions:

Remove & Replace Curb Ramp With Two New Directional Ramps or Equivalent.
