# Access Compliance Report

## Public Rights-of-Way (Curb Ramps)

| Intersection ID: 13085 | Main Street: MORRIS_FIELD_DR | Cross Street: CAPITOL_DR | Location: NE |
| ADA ID: 884B53FB749C | Ramp Type: Perp | Initial Pass/Fail: Fail | Overall Compliance: No |

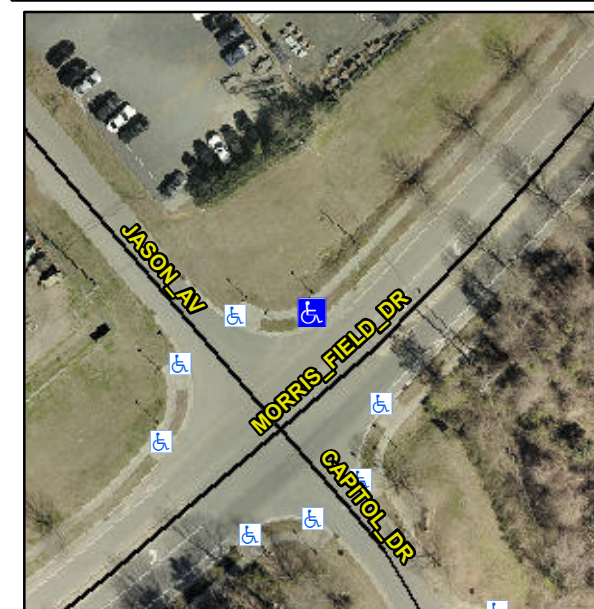
| Codes/Mitigation Info/Possible Solution | | | Severity Score: 10 |

**Not Found, R304.5.1**

| Compliance | Description | Data | Compliance | Description | Data |
|---|---|---|---|---|---|
| N/A | Ramp Length (in) | 70.0 | Yes | Ramp Slope (%) | 5.7 |
| No | Ramp Width (in) | 47.0 | Yes | Ramp XSlope (%) | 2.9 |

**Remove & Replace Entire Ramp.**

Total Cost: \$ 1850.00
