Access Compliance Report Public Rights-of-Way (Curb Ramps)

Intersection ID: 14381 Main Street: CARLTON_AV Cross Street: ROMANY_RD Location: NW ADA ID: 884C2222D33F

Ramp Type: Perp Initial Pass/Fail: Fail **Overall Compliance: No** Severity Score: 13.75

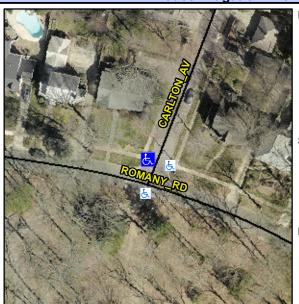
Field Measurements/Component Compliance							
Comp	liance Description	Data	Comp	liance Description	Data		
N/A	Ramp Length (in)	72.0	No	Ramp Slope (%)	8.5		
Yes	Ramp Width (in)	48.0	No	Ramp XSlope (%)	4.9		
N/A	Flare Type LT	N/A	N/A	Flare Type RT	N/A		
N/A	Flare Slope LT (%)	N/A	N/A	Flare Slope RT (%)	N/A		
N/A	Flare Traversable LT?	N/A	N/A	Flare Traversable RT?	N/A		
N/A	Landing Length (in)	N/A	N/A	DWS Provided?	N/A		
N/A	Landing Width (in)	N/A	N/A	DWS Contrast?	N/A		
N/A	Landing Slope (%)	N/A	N/A	DWS Length (in)	N/A		
N/A	Landing X Slope (%)	N/A	N/A	DWS Full Width?	N/A		
N/A	Landing Curb? (Y/N)	N/A	N/A	DWS Offset (in)	N/A		
N/A	Shared Landing?	N/A					
N/A	Gutter Ponding?	N/A	N/A	Gutter Slope (%)	N/A		
N/A	Gutter Lip Ht (in)	N/A	N/A	Gutter X Slope (%)	N/A		
N/A	Painted X Walk1?	No	N/A	Painted X Walk2?	N/A		
	X Walk 1 Direction	То Е		X Walk 2 Direction	N/A		
N/A	X Walk 1 Width (in)	N/A	N/A	X Walk 2 Width (in)	N/A

X Walk 1 Slope (%)	0.9		X Walk 2 Slope (%)	N/A		
	X Walk 1 X Slope (%)	1.8		X Walk 2 X Slope (%)	N/A		
N/A	Ramp inside XWalk1?	N/A	N/A	Ramp inside XWalk2?	N/A		
	Road Slope (%)	N/A	N/A	Clear Space?	N/A		
	Road X Slope (%)	N/A	N/A	Clear Space to XWalk (in)	N/A		
N/A	Any Obstructions?	N/A	N/A	Storm Grate/Utility Hazard?	N/A		
	Obstruction Type			Storm Grate/Utility Type			
		N/A			N/A		
			Yes	Surface Condition? (G/P)	Good		
17 - AND STATE OF THE PARTY OF

Possible Solutions:	9
Remove & Replace Entire Ramp.	N
	Υ
	N
	1
	1
	1
Surveyor Notes:	1
N/A	N
	1
	ľ
	ľ
PROW/ADA:	ľ
Not Found, R304.2.2, R304.5.3	N
	1
	ľ
