# Access Compliance Report

## Public Rights-of-Way

### (Curb Ramps)

Intersection ID: 13149	Main Street: CENTRAL_AV	Cross Street: THE_PLAZA	Location: NE
ADA ID: 88547B7E774F	Ramp Type: Perp	Initial Pass/Fail: Fail	Overall Compliance: No
		Severity Score: 30

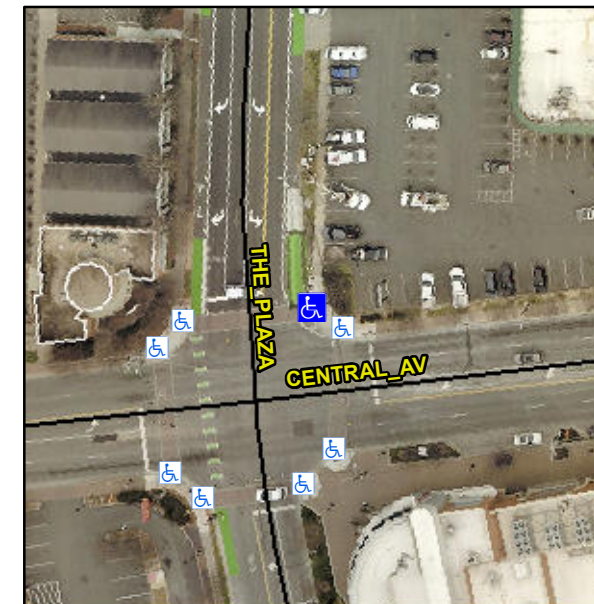
**Not Found, R304.5.1, R304.2.2**

Compliance	Description	Data	Compliance	Description	Data
N/A	Ramp Length (in)	89.0	No	Ramp Slope (%)	10.2
No	Ramp Width (in)	35.5	Yes	Ramp XSlope (%)	1.3
N/A	Flare Type LT	N/A	N/A	Flare Type RT	N/A
N/A	Flare Slope LT (%)	N/A	N/A	Flare Slope RT (%)	N/A
N/A	Flare Traversable LT?	N/A	N/A	Flare Traversable RT?	N/A
N/A	Landing Length (in)	N/A	N/A	DWS Provided?	N/A
N/A	Landing Width (in)	N/A	N/A	DWS Contrast?	N/A
N/A	Landing Slope (%)	N/A	N/A	DWS Length (in)	N/A
N/A	Landing X Slope (%)	N/A	N/A	DWS Full Width?	N/A
N/A	Landing Curb? (Y/N)	N/A	N/A	DWS Offset (in)	N/A
N/A	Shared Landing?	N/A			
N/A	Gutter Ponding?	N/A	N/A	Gutter Slope (%)	N/A
N/A	Gutter Lip Ht (in)	N/A	N/A	Gutter X Slope (%)	N/A
N/A	Painted X Walk1?	Yes	N/A	Painted X Walk2?	N/A
	X Walk 1 Direction	To W		X Walk 2 Direction	N/A
N/A	X Walk 1 Width (in)	96.0	N/A	X Walk 2 Width (in)	N/A
	X Walk 1 Slope (%)	0.5		X Walk 2 Slope (%)	N/A
	X Walk 1 X Slope (%)	0.4		X Walk 2 X Slope (%)	N/A

N/A	Ramp inside XWalk1?	Yes	N/A	Ramp inside XWalk2?	N/A
	Road Slope (%)	N/A	N/A	Clear Space?	N/A
	Road X Slope (%)	N/A	N/A	Clear Space to XWalk (in)	N/A
N/A	Any Obstructions?	N/A	N/A	Storm Grate/Utility Hazard?	N/A
	Obstruction Type			Storm Grate/Utility Type	
		N/A			N/A
		Yes		Surface Condition? (G/P)	Good

**Remove & Replace Entire Ramp.**

Total Cost: \$ 1850.00
