Access Compliance Report Public Rights-of-Way (Curb Ramps)

Intersection ID: 11337	Main Street: DELGANY_DR			Cross Street: TIPPERARY_PL				Location:	NW
ADA ID: 8885D8DB9130	Ramp T	Ramp Type: PerpDiag			Initial Pass/Fail: Fail Overall Compliance: No				10
Codes/Mitigation Info/Possible Solution				Field Measurements/Component Compliance					
	A DECEMBER OF	Possible Solutions:					ata Compliance Description		Data
	6	Remove & Replace Curb Ram	o With	N/A	Ramp Length (in)	57.5		Ramp Slope (%)	6.3
		Two New Directional Ramps of		No	Ramp Width (in)	41.0		Ramp XSlope (%)	3.3
		Equivalent.		N/A	Flare Type LT	N/A	N/A	Flare Type RT	N/A
		5		N/A	Flare Slope LT (%)	N/A	N/A	Flare Slope RT (%)	N/A
				N/A	Flare Traversable LT?	N/A	N/A	Flare Traversable RT?	N/A
				N/A	Landing Length (in)	N/A	N/A	DWS Provided?	N/A
DELGANY DR		Surveyor Notes:		N/A	Landing Width (in)	N/A	N/A	DWS Contrast?	N/A
		N/A		N/A	Landing Slope (%)	N/A	N/A	DWS Length (in)	N/A
				N/A	Landing X Slope (%)	N/A	N/A	DWS Full Width?	N/A

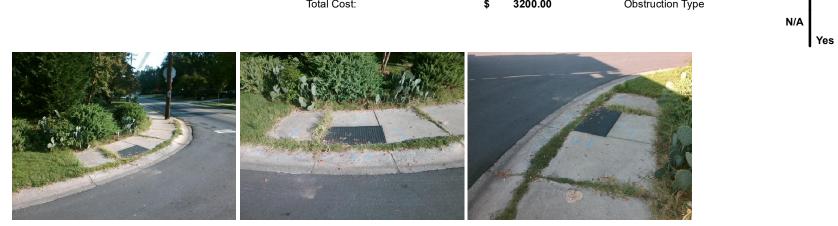
N/A	Landing Curb? (Y/N)	N/A	N/A	DWS Offset (in)	N/A
the second se		-		N/A	Shared Landing?	N/A			
		PROW/ADA:		N/A	Gutter Ponding?	N/A	N/A	Gutter Slope (%)	N/A
A Bridge And and and		Not Found, R304.5.1, R304.5.3	2	N/A	Gutter Lip Ht (in)	N/A	N/A	Gutter X Slope (%)	N/A
	Harry	Not i ound, 1004.0.1, 1004.0.0		N/A	Painted X Walk1?	No	N/A	Painted X Walk2?	No
	Tradition				X Walk 1 Direction	To S		X Walk 2 Direction	To E
All of the second second				N/A	X Walk 1 Width (in)	N/A	N/A	X Walk 2 Width (in)	N/A
Street 1 Name	DELGANY DR	-			X Walk 1 Slope (%)	2.1		X Walk 2 Slope (%)	3.4
Stop Condition-Street 2	StopSign				X Walk 1 X Slope (%)	2.3		X Walk 2 X Slope (%)	0.9
Street 2 Name	TIPPERAEY PL			N/A	Ramp inside XWalk1?	N/A	N/A	Ramp inside XWalk2?	N/A
Stop Condition-Street 1	StopSign				Road Slope (%)	1.9	N/A	Clear Space?	N/A
	. • 5				Road X Slope (%)	5.6	N/A	Clear Space to XWalk (in)	N/A
				N/A	Any Obstructions?	N/A	N/A	Storm Grate/Utility Hazard?	N/A

Total Cost: \$	3200.00		Obstruction Type			Storm Grate/Utility Type	
						N/A			N/A
