# Access Compliance Report Public Rights-of-Way (Curb Ramps)

Intersection ID: 29232      Main Street: ROCKWELL\_BV      Cross Street: ROCKWELL\_BV\_WEST      Location: E

ADA ID: 88AC3EB53E99      Ramp Type: Para      Initial Pass/Fail: Fail      Overall Compliance: No      Severity Score: 18.75

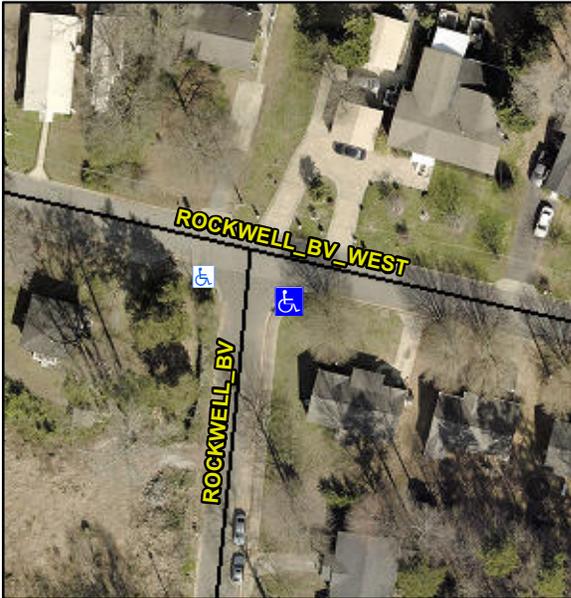
PROW/ADA:  
**R304.5.1, R304.5.3**

Compliance	Description	Data	Compliance	Description	Data
N/A	Ramp Length LT (in)	58.0	N/A	Ramp Length RT (in)	47.0
No	Ramp Width LT (in)	35.0	No	Ramp Width RT (in)	35.0
Yes	Ramp Slope LT (%)	8.2	Yes	Ramp Slope RT (%)	5.1
No	Ramp XSlope LT (%)	5.0	No	Ramp XSlope RT (%)	3.7
N/A	Landing Length (in)	N/A	N/A	DWS Provided?	N/A
N/A	Landing Width (in)	N/A	N/A	DWS Contrast?	N/A
N/A	Landing Slope (%)	N/A	N/A	DWS Length (in)	N/A
N/A	Landing X Slope (%)	N/A	N/A	DWS Full Width?	N/A
N/A	Landing Curb? (Y/N)	N/A	N/A	DWS Offset (in)	N/A
N/A	Shared Landing?	N/A			
N/A	Gutter Ponding?	N/A	N/A	Gutter Slope (%)	N/A
N/A	Gutter Lip Ht (in)	0.5	N/A	Gutter X Slope (%)	N/A
N/A	Painted X Walk1?	No	N/A	Painted X Walk2?	N/A
	X Walk 1 Direction	To W		X Walk 2 Direction	N/A
N/A	X Walk 1 Width (in)	N/A	N/A	X Walk 2 Width (in)	N/A
	X Walk 1 Slope (%)	4.1		X Walk 2 Slope (%)	N/A
	X Walk 1 X Slope (%)	1.8		X Walk 2 X Slope (%)	N/A
N/A	Ramp inside XWalk1?	N/A	N/A	Ramp inside XWalk2?	N/A

Road Slope (%)	N/A	N/A	Clear Space?	N/A
	Road X Slope (%)	N/A	N/A	Clear Space to XWalk (in)	N/A
N/A	Any Obstructions?	N/A	N/A	Storm Grate/Utility Hazard?	N/A
	Obstruction Type			Storm Grate/Utility Type	
	Total Cost:	\$ 1600.00	N/A		N/A
			Yes	Surface Condition? (G/P)	Good
			N/A	Curb Slope (%)	20.5

Possible Solutions:  
**Remove & Replace Entire Ramp.**
