# Access Compliance Report

## Public Rights-of-Way (Curb Ramps)

Intersection ID: 10025397	Main Street: E_ARROWOOD_RD	Cross Street: N/A	Location: NE
ADA ID: 88ED0E878DB2	Ramp Type: Directional1	Initial Pass/Fail: Fail	Overall Compliance: No
		Severity Score: 12.5

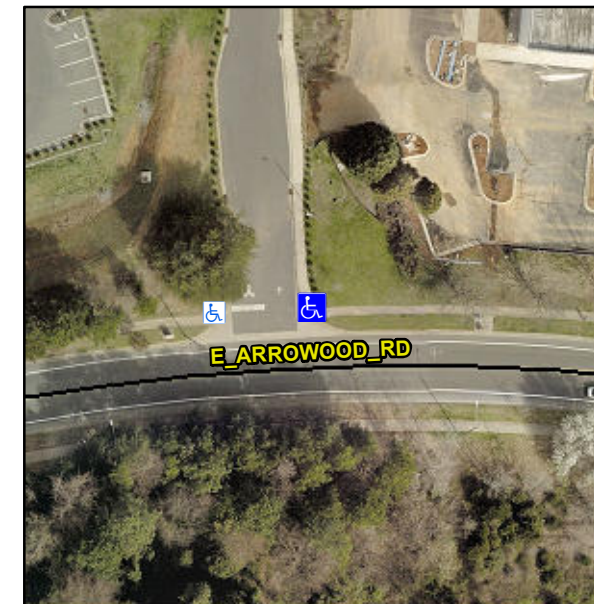
Compliance	Description	Data	Compliance	Description	Data
N/A	Ramp Length (in)	131.0	N/A	Grade Break?	N/A
Yes	Ramp Width (in)	72.0	N/A	Grade Break Slope (%)	0.0
Yes	Ramp Slope (%)	3.1	N/A	Grade Break XSlope (%)	0.0
No	Ramp XSlope (%)	5.6			
N/A	Flare Type LT	N/A	N/A	Flare Type RT	N/A
N/A	Flare Slope LT (%)	N/A	N/A	Flare Slope RT (%)	0.0
N/A	Flare Traversable LT?	N/A	N/A	Flare Traversable RT?	N/A
N/A	Landing Length (in)	0.0	N/A	DWS Provided?	N/A
N/A	Landing Width (in)	0.0	N/A	DWS Contrast?	N/A
N/A	Landing Slope (%)	0.0	N/A	DWS Length (in)	N/A
N/A	Landing X Slope (%)	0.0	N/A	DWS Full Width?	N/A
N/A	Landing Curb? (Y/N)	N/A	N/A	DWS Offset LT (in)	N/A
N/A	Shared Landing?	N/A	N/A	DWS Offset RT (in)	N/A
N/A	Gutter Ponding?	0.0	N/A	Gutter Slope (%)	N/A
N/A	Gutter Lip Ht (in)	0.0	N/A	Gutter X Slope (%)	N/A
N/A	Painted X Walk1?	No		Road Slope (%)	1.1
	X Walk 1 Direction	To W		Road X Slope (%)	2.3
	X Walk 1 Width (in)	N/A		Clear Space?	N/A

X Walk 1 Slope (%)	1.1	N/A	Clear Space to XWalk (in)	N/A
	X Walk 1 X Slope (%)	2.3	N/A	Storm Grate/Utility Hazard?	N/A
N/A	Ramp inside XWalk1?	N/A		Storm Grate/Utility Type	
N/A	Any Obstructions?	N/A			N/A
	Obstruction Type		Yes	Surface Condition? (G/P)	Good
			N/A	Curb Slope (%)	1.9

**Remove & Replace Entire Ramp.**
