## **Access Compliance Report Public Rights-of-Way** (Curb Ramps)

Intersection ID: 30255 Main Street: OLD IRONSIDE DR **Cross Street: WYLAM DILLY CT** Location: N Ramp Type: PerpDiag Initial Pass/Fail: Fail **Overall Compliance: No Severity Score:** 25 ADA ID: 88F06B692453

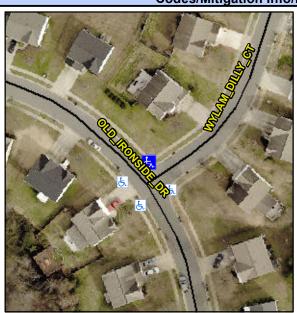
Compliance Description I		Data	Comp	liance Description	Data
N/A	Ramp Length (in)	47.0	No	Ramp Slope (%)	14.6
Yes	Ramp Width (in)	55.0	Yes	Ramp XSlope (%)	0.5
N/A	Flare Type LT	N/A	N/A	Flare Type RT	N/A
N/A	Flare Slope LT (%)	N/A	N/A	Flare Slope RT (%)	N/A
N/A	Flare Traversable LT?	N/A	N/A	Flare Traversable RT?	N/A
N/A	Landing Length (in)	N/A	N/A	DWS Provided?	N/A
N/A	Landing Width (in)	N/A	N/A	DWS Contrast?	N/A
N/A	Landing Slope (%)	N/A	N/A	DWS Length (in)	N/A
N/A	Landing X Slope (%)	N/A	N/A	DWS Full Width?	N/A
N/A	Landing Curb? (Y/N)	N/A	N/A	DWS Offset (in)	N/A
N/A	Shared Landing?	N/A			
N/A	Gutter Ponding?	N/A	N/A	Gutter Slope (%)	N/A
N/A	Gutter Lip Ht (in)	N/A	N/A	Gutter X Slope (%)	N/A
N/A	Painted X Walk1?	No	N/A	Painted X Walk2?	No
	X Walk 1 Direction	To W		X Walk 2 Direction	To SE
N/A	X Walk 1 Width (in)	N/A	N/A	X Walk 2 Width (in)	N/A
	X Walk 1 Slope (%)	1.5		X Walk 2 Slope (%)	1.3
	X Walk 1 X Slope (%)	1.9		X Walk 2 X Slope (%)	1.7

N/A	Ramp inside XWalk1?	N/A	N/A	Ramp inside XWalk2?	N/A
	Road Slope (%)	1.6	N/A	Clear Space?	N/A
	Road X Slope (%)	0.8	N/A	Clear Space to XWalk (in)	N/A
N/A	Any Obstructions?	N/A	N/A	Storm Grate/Utility Hazard?	N/A
	Obstruction Type		l	Storm Grate/Utility Type	
		N/A			N/A
			Yes	Surface Condition? (G/P)	Good

Possible Solutions: Remove & Replace Curb Ramp With Two New Directional Ramps or Equivalent. Surveyor Notes:

Not Found, R304.2.2
