# Access Compliance Report

## Public Rights-of-Way

### (Curb Ramps)

Intersection ID: 10038838	Main Street: STEELECROFT_PY	Cross Street: N/A	Location: SW
ADA ID: 8910D7F4414A	Ramp Type: PerpDiag	Initial Pass/Fail: Fail	Overall Compliance: No
Severity Score: 8.75			
Codes/Mitigation Info/Possible Solution		Field Measurements/Component Compliance

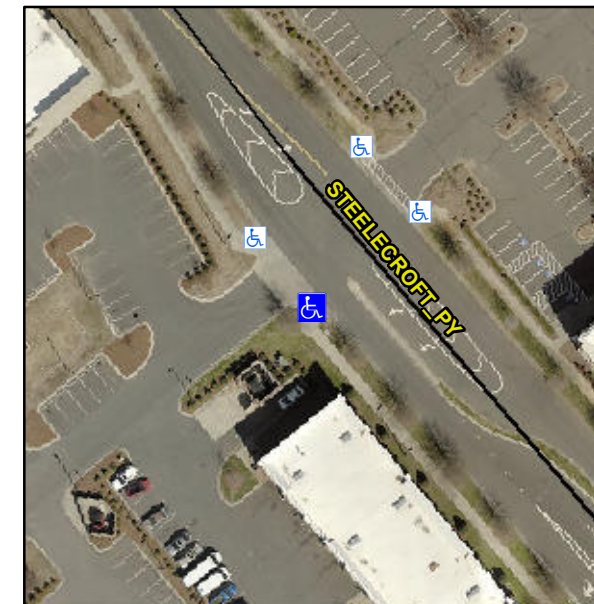
Compliance	Description	Data	Compliance	Description	Data
N/A	Ramp Length (in)	101.0	Yes	Ramp Slope (%)	7.5
No	Ramp Width (in)	42.0	Yes	Ramp XSlope (%)	1.9
N/A	Flare Type LT	N/A	N/A	Flare Type RT	N/A
N/A	Flare Slope LT (%)	N/A	N/A	Flare Slope RT (%)	N/A
N/A	Flare Traversable LT?	N/A	N/A	Flare Traversable RT?	N/A
N/A	Landing Length (in)	N/A	N/A	DWS Provided?	N/A
N/A	Landing Width (in)	N/A	N/A	DWS Contrast?	N/A
N/A	Landing Slope (%)	N/A	N/A	DWS Length (in)	N/A
N/A	Landing X Slope (%)	N/A	N/A	DWS Full Width?	N/A
N/A	Landing Curb? (Y/N)	N/A	N/A	DWS Offset (in)	N/A
N/A	Shared Landing?	N/A			
N/A	Gutter Ponding?	N/A	N/A	Gutter Slope (%)	N/A
N/A	Gutter Lip Ht (in)	N/A	N/A	Gutter X Slope (%)	N/A
N/A	Painted X Walk1?	No	N/A	Painted X Walk2?	No
	X Walk 1 Direction	To NE		X Walk 2 Direction	To NW
N/A	X Walk 1 Width (in)	N/A	N/A	X Walk 2 Width (in)	N/A
	X Walk 1 Slope (%)	2.3		X Walk 2 Slope (%)	0.4
	X Walk 1 X Slope (%)	2.1		X Walk 2 X Slope (%)	2.2

N/A	Ramp inside XWalk1?	N/A	N/A	Ramp inside XWalk2?	N/A
	Road Slope (%)	1.6	N/A	Clear Space?	N/A
	Road X Slope (%)	2.8	N/A	Clear Space to XWalk (in)	N/A
N/A	Any Obstructions?	N/A	N/A	Storm Grate/Utility Hazard?	N/A
	Obstruction Type			Storm Grate/Utility Type	
		N/A			N/A
			Yes	Surface Condition? (G/P)	Good

**Remove & Replace Curb Ramp With Two New Directional Ramps or Equivalent.**

**Not Found, R304.5.1**
