Access Compliance Report

Public Rights-of-Way

(Curb Ramps)

Intersection ID: N/A	Main Street: PERWINKLE_HILL_CT	Cross Street: N/A	Location: S
ADA ID: 8911A69C7DF5	Ramp Type: Perp	Initial Pass/Fail: Fail	Overall Compliance: No
		Severity Score: 25

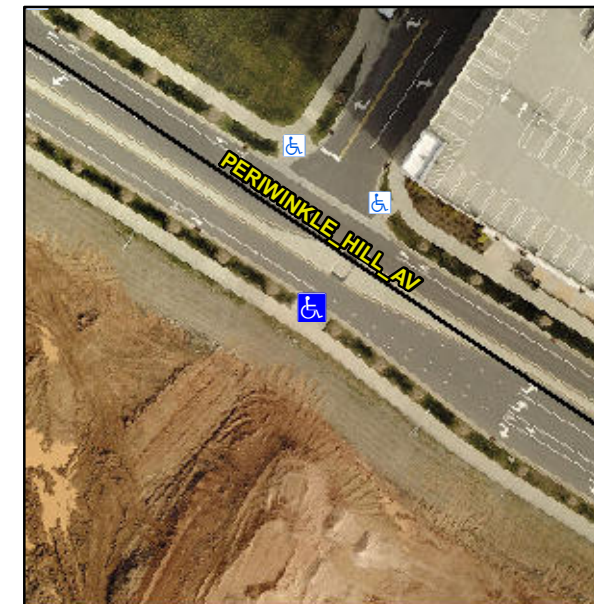
Not Found, R304.5.3

Compliance	Description	Data	Compliance	Description	Data
N/A	Ramp Length (in)	94.0	Yes	Ramp Slope (%)	7.2
Yes	Ramp Width (in)	60.0	No	Ramp XSlope (%)	7.8
N/A	Flare Type LT	N/A	N/A	Flare Type RT	N/A
N/A	Flare Slope LT (%)	N/A	N/A	Flare Slope RT (%)	N/A
N/A	Flare Traversable LT?	N/A	N/A	Flare Traversable RT?	N/A
N/A	Landing Length (in)	N/A	N/A	DWS Provided?	N/A
N/A	Landing Width (in)	N/A	N/A	DWS Contrast?	N/A
N/A	Landing Slope (%)	N/A	N/A	DWS Length (in)	N/A
N/A	Landing X Slope (%)	N/A	N/A	DWS Full Width?	N/A
N/A	Landing Curb? (Y/N)	N/A	N/A	DWS Offset (in)	N/A
N/A	Shared Landing?	N/A			
N/A	Gutter Ponding?	N/A	N/A	Gutter Slope (%)	N/A
N/A	Gutter Lip Ht (in)	N/A	N/A	Gutter X Slope (%)	N/A
N/A	Painted X Walk1?	No	N/A	Painted X Walk2?	N/A
	X Walk 1 Direction	To NE		X Walk 2 Direction	N/A
N/A	X Walk 1 Width (in)	N/A	N/A	X Walk 2 Width (in)	N/A
	X Walk 1 Slope (%)	2.4		X Walk 2 Slope (%)	N/A
	X Walk 1 X Slope (%)	4.3		X Walk 2 X Slope (%)	N/A

Remove & Replace Entire Ramp.

Total Cost: \$ 1850.00
