Access Compliance Report

Public Rights-of-Way

(Curb Ramps)

Intersection ID: 15849	Main Street: NORTON_RD	Cross Street: QUEENS_RD_WEST	Location: NW
ADA ID: 8913564B36FF	Ramp Type: PerpDiag	Initial Pass/Fail: Fail	Overall Compliance: No
Severity Score: 10			
Codes/Mitigation Info/Possible Solution		Field Measurements/Component Compliance

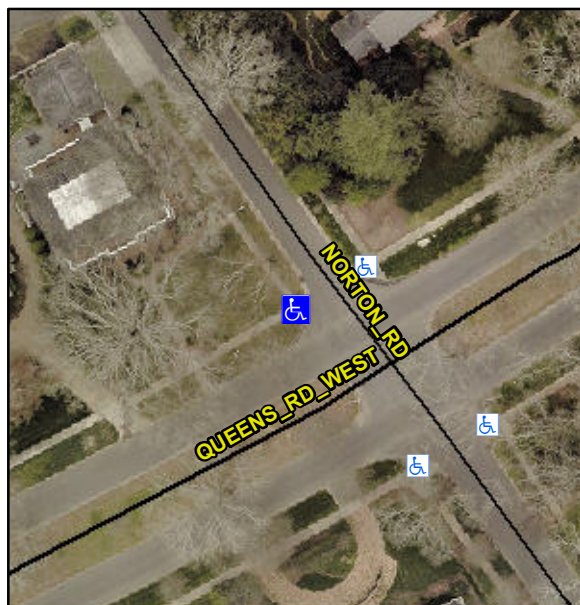
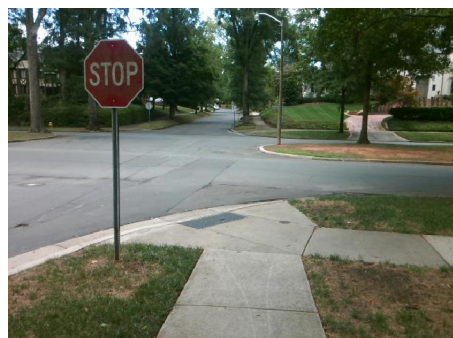
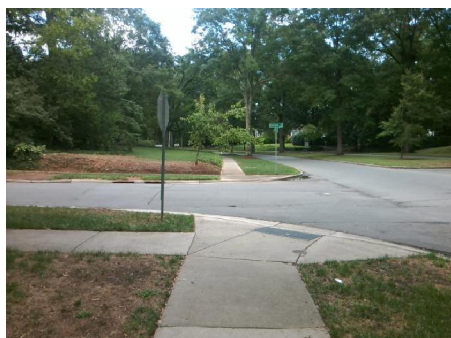
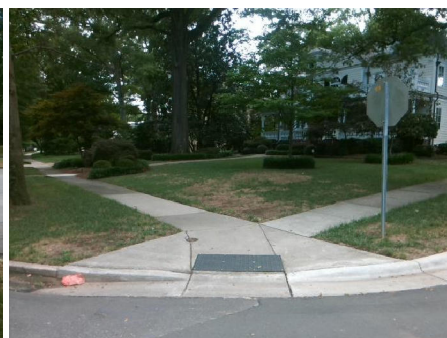
Compliance	Description	Data	Compliance	Description	Data
N/A	Ramp Length (in)	26.0	Yes	Ramp Slope (%)	6.4
No	Ramp Width (in)	47.0	No	Ramp XSlope (%)	4.0
N/A	Flare Type LT	N/A	N/A	Flare Type RT	N/A
N/A	Flare Slope LT (%)	N/A	N/A	Flare Slope RT (%)	N/A
N/A	Flare Traversable LT?	N/A	N/A	Flare Traversable RT?	N/A
N/A	Landing Length (in)	N/A	N/A	DWS Provided?	N/A
N/A	Landing Width (in)	N/A	N/A	DWS Contrast?	N/A
N/A	Landing Slope (%)	N/A	N/A	DWS Length (in)	N/A
N/A	Landing X Slope (%)	N/A	N/A	DWS Full Width?	N/A
N/A	Landing Curb? (Y/N)	N/A	N/A	DWS Offset (in)	N/A
N/A	Shared Landing?	N/A			
N/A	Gutter Ponding?	N/A	N/A	Gutter Slope (%)	N/A
N/A	Gutter Lip Ht (in)	N/A	N/A	Gutter X Slope (%)	N/A
N/A	Painted X Walk1?	No	N/A	Painted X Walk2?	No
	X Walk 1 Direction	To SE		X Walk 2 Direction	To E
N/A	X Walk 1 Width (in)	N/A	N/A	X Walk 2 Width (in)	N/A
	X Walk 1 Slope (%)	1.7		X Walk 2 Slope (%)	0.9
	X Walk 1 X Slope (%)	2.1		X Walk 2 X Slope (%)	0.7

N/A	Ramp inside XWalk1?	N/A	N/A	Ramp inside XWalk2?	N/A
	Road Slope (%)	4.1	N/A	Clear Space?	N/A
	Road X Slope (%)	4.4	N/A	Clear Space to XWalk (in)	N/A
N/A	Any Obstructions?	N/A	N/A	Storm Grate/Utility Hazard?	N/A
	Obstruction Type			Storm Grate/Utility Type	
		N/A			N/A
		Yes		Surface Condition? (G/P)	Good

Remove & Replace Curb Ramp With Two New Directional Ramps or Equivalent.
