# Access Compliance Report

## Public Rights-of-Way

### (Curb Ramps)

Intersection ID: N/A	Main Street: BROOKSVALE_ST	Cross Street: BURNETTE_AV	Location: SE
ADA ID: 891C973B711A	Ramp Type: PerpDiag	Initial Pass/Fail: Fail	Overall Compliance: No
Severity Score: 46.25			
Codes/Mitigation Info/Possible Solution		Field Measurements/Component Compliance

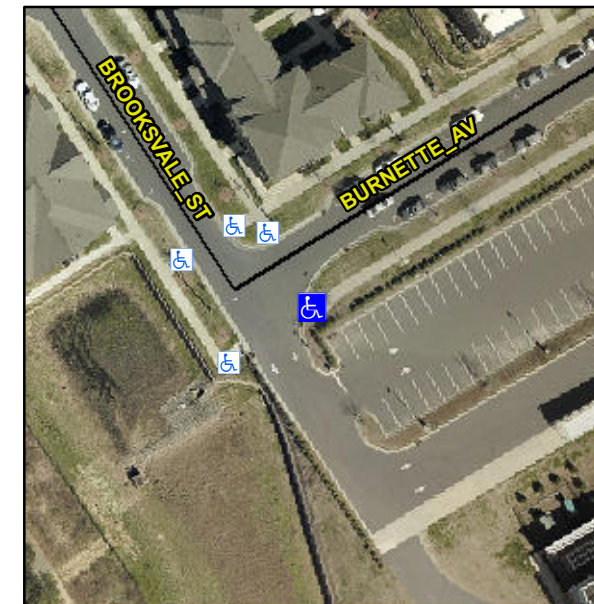
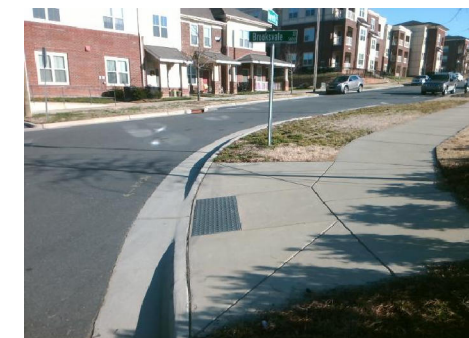
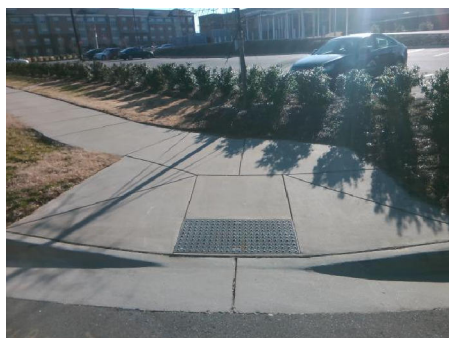
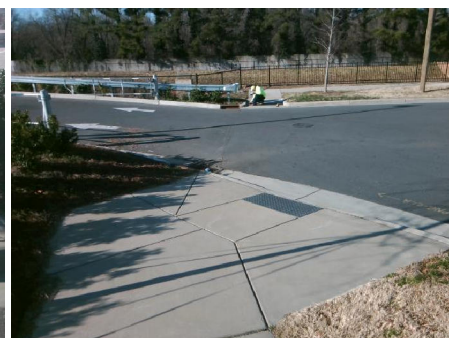
**Not Found, R304.5.1, R304.2.2, R304.5.3**

Compliance	Description	Data	Compliance	Description	Data
N/A	Ramp Length (in)	74.0	No	Ramp Slope (%)	9.0
No	Ramp Width (in)	47.5	No	Ramp XSlope (%)	8.4
N/A	Flare Type LT	N/A	N/A	Flare Type RT	N/A
N/A	Flare Slope LT (%)	N/A	N/A	Flare Slope RT (%)	N/A
N/A	Flare Traversable LT?	N/A	N/A	Flare Traversable RT?	N/A
N/A	Landing Length (in)	N/A	N/A	DWS Provided?	N/A
N/A	Landing Width (in)	N/A	N/A	DWS Contrast?	N/A
N/A	Landing Slope (%)	N/A	N/A	DWS Length (in)	N/A
N/A	Landing X Slope (%)	N/A	N/A	DWS Full Width?	N/A
N/A	Landing Curb? (Y/N)	N/A	N/A	DWS Offset (in)	N/A
N/A	Shared Landing?	N/A			
N/A	Gutter Ponding?	N/A	N/A	Gutter Slope (%)	N/A
N/A	Gutter Lip Ht (in)	N/A	N/A	Gutter X Slope (%)	N/A
N/A	Painted X Walk1?	No	N/A	Painted X Walk2?	No
	X Walk 1 Direction	To NW		X Walk 2 Direction	To SW
N/A	X Walk 1 Width (in)	N/A	N/A	X Walk 2 Width (in)	N/A
	X Walk 1 Slope (%)	0.7		X Walk 2 Slope (%)	1.5
	X Walk 1 X Slope (%)	4.3		X Walk 2 X Slope (%)	3.2

N/A	Ramp inside XWalk1?	N/A	N/A	Ramp inside XWalk2?	N/A
	Road Slope (%)	5.9	N/A	Clear Space?	N/A
	Road X Slope (%)	0.7	N/A	Clear Space to XWalk (in)	N/A
N/A	Any Obstructions?	N/A	N/A	Storm Grate/Utility Hazard?	N/A
	Obstruction Type			Storm Grate/Utility Type	
		N/A			N/A
			Yes	Surface Condition? (G/P)	Good

**Remove & Replace Curb Ramp With Two New Directional Ramps or Equivalent.**

Total Cost: \$ 3200.00
