# Access Compliance Report

## Public Rights-of-Way

### (Curb Ramps)

Intersection ID: 31713	Main Street: WEEPING FIG LN	Cross Street: ALDER CT	Location: SW
ADA ID: 891F1E2A2539	Ramp Type: PerpDiag	Initial Pass/Fail: Fail	Overall Compliance: No
			Severity Score: 21.25

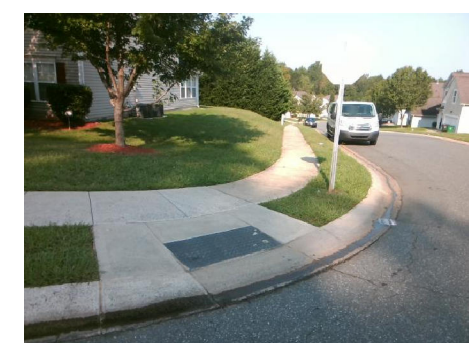
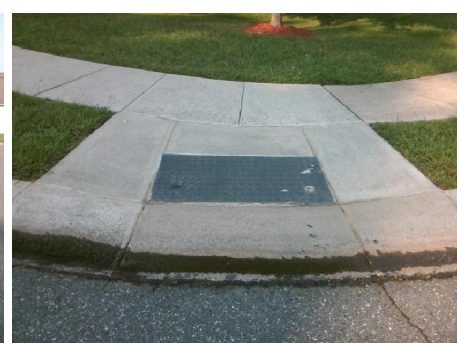
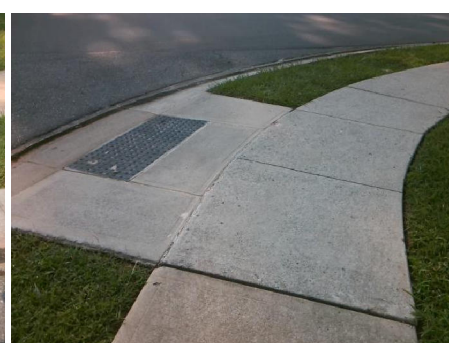
Possible Solutions:		Compliance	Description	Data	Compliance	Description	Data
	Remove & Replace Curb Ramp With Two New Directional Ramps or Equivalent.		N/A	Ramp Length (in)	47.5	Yes	Ramp Slope (%)	5.3
			No	Ramp Width (in)	46.0	No	Ramp XSlope (%)	5.9
			N/A	Flare Type LT	N/A	N/A	Flare Type RT	N/A
			N/A	Flare Slope LT (%)	N/A	N/A	Flare Slope RT (%)	N/A
			N/A	Flare Traversable LT?	N/A	N/A	Flare Traversable RT?	N/A
			N/A	Landing Length (in)	N/A	N/A	DWS Provided?	N/A
			N/A	Landing Width (in)	N/A	N/A	DWS Contrast?	N/A
			N/A	Landing Slope (%)	N/A	N/A	DWS Length (in)	N/A
			N/A	Landing X Slope (%)	N/A	N/A	DWS Full Width?	N/A
Surveyor Notes:		N/A	N/A	Landing Curb? (Y/N)	N/A	N/A	DWS Offset (in)	N/A
PROW/ADA:		Not Found, R304.5.1, R304.5.3	N/A	Shared Landing?	N/A			
			N/A	Gutter Ponding?	N/A	N/A	Gutter Slope (%)	N/A

N/A	Gutter Lip Ht (in)	N/A	N/A	Gutter X Slope (%)	N/A
			N/A	Painted X Walk1?	No	N/A	Painted X Walk2?	No
				X Walk 1 Direction	To E		X Walk 2 Direction	To NE
			N/A	X Walk 1 Width (in)	N/A	N/A	X Walk 2 Width (in)	N/A
				X Walk 1 Slope (%)	8.6		X Walk 2 Slope (%)	2.1
				X Walk 1 X Slope (%)	0.6		X Walk 2 X Slope (%)	6.1
			N/A	Ramp inside XWalk1?	N/A	N/A	Ramp inside XWalk2?	N/A
				Road Slope (%)	5.9	N/A	Clear Space?	N/A
				Road X Slope (%)	6.9	N/A	Clear Space to XWalk (in)	N/A
			N/A	Any Obstructions?	N/A	N/A	Storm Grate/Utility Hazard?	N/A
				Obstruction Type			Storm Grate/Utility Type	
					N/A			N/A
						Yes	Surface Condition? (G/P)	Good
