Access Compliance Report

Public Rights-of-Way

(Curb Ramps)

Intersection ID: 22673	Main Street: BRACKENBURY_LN	Cross Street: HILLANDALE_DR	Location: NE
ADA ID: 89201ECCEF59	Ramp Type: Perp	Initial Pass/Fail: Fail	Overall Compliance: No
Severity Score: 22.5			
Codes/Mitigation Info/Possible Solution		Field Measurements/Component Compliance

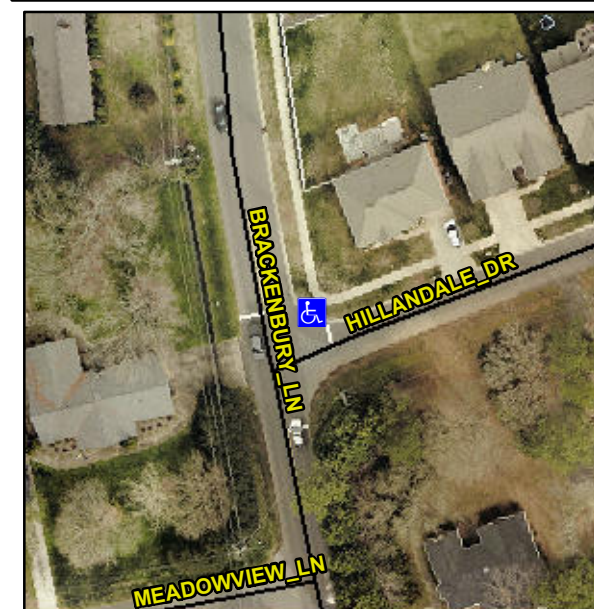
Not Found, R304.5.1, R304.2.2, R304.5.3

Compliance	Description	Data	Compliance	Description	Data
N/A	Ramp Length (in)	96.0	No	Ramp Slope (%)	8.6
No	Ramp Width (in)	47.0	No	Ramp XSlope (%)	2.2
N/A	Flare Type LT	N/A	N/A	Flare Type RT	N/A
N/A	Flare Slope LT (%)	N/A	N/A	Flare Slope RT (%)	N/A
N/A	Flare Traversable LT?	N/A	N/A	Flare Traversable RT?	N/A
N/A	Landing Length (in)	N/A	N/A	DWS Provided?	N/A
N/A	Landing Width (in)	N/A	N/A	DWS Contrast?	N/A
N/A	Landing Slope (%)	N/A	N/A	DWS Length (in)	N/A
N/A	Landing X Slope (%)	N/A	N/A	DWS Full Width?	N/A
N/A	Landing Curb? (Y/N)	N/A	N/A	DWS Offset (in)	N/A
N/A	Shared Landing?	N/A			
N/A	Gutter Ponding?	N/A	N/A	Gutter Slope (%)	N/A
N/A	Gutter Lip Ht (in)	N/A	N/A	Gutter X Slope (%)	N/A
N/A	Painted X Walk1?	No	N/A	Painted X Walk2?	N/A
	X Walk 1 Direction	To S		X Walk 2 Direction	N/A
N/A	X Walk 1 Width (in)	N/A	N/A	X Walk 2 Width (in)	N/A
	X Walk 1 Slope (%)	1.7		X Walk 2 Slope (%)	N/A
	X Walk 1 X Slope (%)	4.0		X Walk 2 X Slope (%)	N/A

N/A	Ramp inside XWalk1?	N/A	N/A	Ramp inside XWalk2?	N/A
	Road Slope (%)	4.0	N/A	Clear Space?	N/A
	Road X Slope (%)	1.7	N/A	Clear Space to XWalk (in)	N/A
N/A	Any Obstructions?	N/A	N/A	Storm Grate/Utility Hazard?	N/A
	Obstruction Type			Storm Grate/Utility Type	
		N/A			N/A
			Yes	Surface Condition? (G/P)	Good

Remove & Replace Entire Ramp.

Total Cost: \$ 1850.00
