Access Compliance Report

Public Rights-of-Way

(Curb Ramps)

Intersection ID: 51243	Main Street: NORTHCREST SHOPPING CENTER DR	Cross Street: W W T HARRIS BV	Location: SW
ADA ID: 892C6E973A73	Ramp Type: PerpDiag	Initial Pass/Fail: Fail	Overall Compliance: No
		Severity Score: 22.5

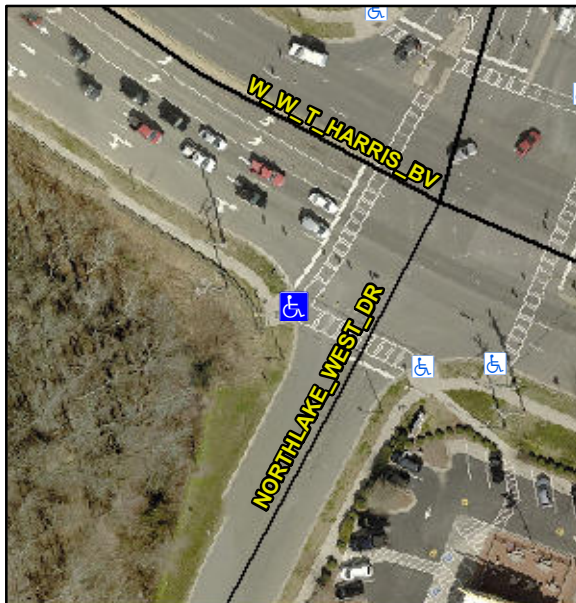
Not Found, R304.5.1, R304.2.2, R304.5.3

Compliance	Description	Data	Compliance	Description	Data
N/A	Ramp Length (in)	94.0	No	Ramp Slope (%)	8.4
No	Ramp Width (in)	46.0	No	Ramp XSlope (%)	2.5
N/A	Flare Type LT	N/A	N/A	Flare Type RT	N/A
N/A	Flare Slope LT (%)	N/A	N/A	Flare Slope RT (%)	N/A
N/A	Flare Traversable LT?	N/A	N/A	Flare Traversable RT?	N/A
N/A	Landing Length (in)	N/A	N/A	DWS Provided?	N/A
N/A	Landing Width (in)	N/A	N/A	DWS Contrast?	N/A
N/A	Landing Slope (%)	N/A	N/A	DWS Length (in)	N/A
N/A	Landing X Slope (%)	N/A	N/A	DWS Full Width?	N/A
N/A	Landing Curb? (Y/N)	N/A	N/A	DWS Offset (in)	N/A
N/A	Shared Landing?	N/A			
N/A	Gutter Ponding?	N/A	N/A	Gutter Slope (%)	N/A
N/A	Gutter Lip Ht (in)	N/A	N/A	Gutter X Slope (%)	N/A
N/A	Painted X Walk1?	Yes	N/A	Painted X Walk2?	Yes
	X Walk 1 Direction	To SE		X Walk 2 Direction	To NE
N/A	X Walk 1 Width (in)	108.0	N/A	X Walk 2 Width (in)	75.0
	X Walk 1 Slope (%)	1.4		X Walk 2 Slope (%)	0.8
	X Walk 1 X Slope (%)	0.8		X Walk 2 X Slope (%)	1.3

N/A	Ramp inside XWalk1?	Yes	N/A	Ramp inside XWalk2?	Yes
	Road Slope (%)	1.4	N/A	Clear Space?	N/A
	Road X Slope (%)	1.7	N/A	Clear Space to XWalk (in)	N/A
N/A	Any Obstructions?	N/A	N/A	Storm Grate/Utility Hazard?	N/A
	Obstruction Type			Storm Grate/Utility Type	
		N/A			N/A
		Yes		Surface Condition? (G/P)	Good

Remove & Replace Curb Ramp With Two New Directional Ramps or Equivalent.
