## **Access Compliance Report Public Rights-of-Way** (Curb Ramps)

Location: Intersection ID: 3637 Main Street: SHENINGTON PL Cross Street: TREYBURN DR NE Initial Pass/Fail: Fail **Overall Compliance: No** ADA ID: 89363C42877A Ramp Type: BlendTrans2 **Severity Score:** 8.75

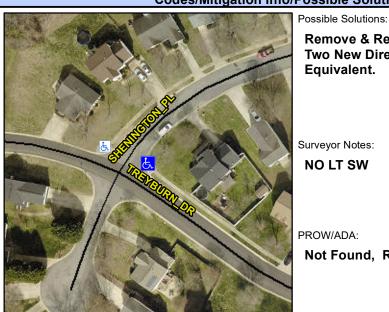
Surveyor Notes: **NO LT SW**

N/A	Ramp Length (in)	98.0	Yes	BlendTrans Slope (%)
No	Ramp Width (in)	46.0	Yes	BlendTrans XSlope (%)
N/A	Flare Type LT	N/A	N/A	Flare Type RT
N/A	Flare Slope LT (%)	N/A	N/A	Flare Slope RT (%)
N/A	Flare Traversable LT?	N/A	N/A	Flare Traversable RT?
N/A	Landing Length (in)	N/A	N/A	DWS Provided?
N/A	Landing Width (in)	N/A	N/A	DWS Contrast?
N/A	Landing Slope (%)	N/A	N/A	DWS Length (in)
N/A	Landing X Slope (%)	N/A	N/A	DWS Full Width?
N/A	Landing Curb? (Y/N)	N/A	N/A	DWS Offset (in)
N/A	Shared Landing?	N/A		
N/A	Gutter Ponding?	N/A	N/A	Gutter Slope (%)
N/A	Gutter Lip Ht (in)	N/A	N/A	Gutter X Slope (%)
N/A	Painted X Walk1?	No	N/A	Painted X Walk2?
	X Walk 1 Direction	To NW		X Walk 2 Direction
	X Walk 1 Width (in)	N/A		X Walk 2 Width (in)
	X Walk 1 Slope (%)	0.3		X Walk 2 Slope (%)
	X Walk 1 X Slope (%)	0.1		X Walk 2 X Slope (%)
N/A	Ramp inside XWalk1?	N/A	N/A	Ramp inside XWalk2?
	Road Slope (%)	0.1		Clear Space?
	Road X Slope (%)	0.3	N/A	Clear Space to XWalk (in)

Street 1 Name Stop Condition-Street 1 Street 2 Name Stop Condition-Street 2 Remove & Replace Curb Ramp With Two New Directional Ramps or Equivalent.
