Access Compliance Report Public Rights-of-Way (Curb Ramps)

Intersection ID: 11594Main Street:BELFAST_DRCross Street:ORTON_STLocation:NEADA ID: 893B17D1EA28Ramp Type:BlendTrans2Initial Pass/Fail:FailOverall Compliance:NoSeverity Score:10

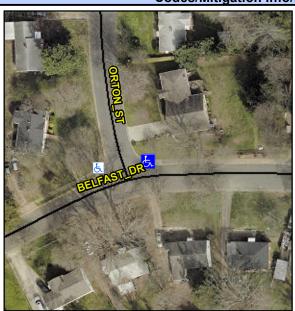
NO LT SW

Not Found, R304.5.1, R304.5.3

Field Measurements/Component Compliance					
Compliance Description		Data	Compliance Description		Data
N/A	Ramp Length (in)	51.0	Yes	BlendTrans Slope (%)	1.6
No	Ramp Width (in)	47.5	No	BlendTrans XSlope (%)	2.6
N/A	Flare Type LT	N/A	N/A	Flare Type RT	N/A
N/A	Flare Slope LT (%)	N/A	N/A	Flare Slope RT (%)	N/A
N/A	Flare Traversable LT?	N/A	N/A	Flare Traversable RT?	N/A
N/A	Landing Length (in)	N/A	N/A	DWS Provided?	N/A
N/A	Landing Width (in)	N/A	N/A	DWS Contrast?	N/A
N/A	Landing Slope (%)	N/A	N/A	DWS Length (in)	N/A
N/A	Landing X Slope (%)	N/A	N/A	DWS Full Width?	N/A
N/A	Landing Curb? (Y/N)	N/A	N/A	DWS Offset (in)	N/A
N/A	Shared Landing?	N/A			
N/A	Gutter Ponding?	N/A	N/A	Gutter Slope (%)	N/A
N/A	Gutter Lip Ht (in)	N/A	N/A	Gutter X Slope (%)	N/A
N/A	Painted X Walk1?	No	N/A	Painted X Walk2?	N/A
	X Walk 1 Direction	To W		X Walk 2 Direction	N/A
	X Walk 1 Width (in)	N/A		X Walk 2 Width (in)	N/A
	X Walk 1 Slope (%)	8.8		X Walk 2 Slope (%)	N/A

X Walk 1 X Slope (%)	2.0		X Walk 2 X Slope (%)	N/A
N/A	Ramp inside XWalk1?	N/A	N/A	Ramp inside XWalk2?	N/A
	Road Slope (%)	2.0		Clear Space?	N/A
	Road X Slope (%)	8.8	N/A	Clear Space to XWalk (in)	N/A
N/A	Any Obstructions?	N/A	N/A	Storm Grate/Utility Hazard?	N/A
	Obstruction Type		l	Storm Grate/Utility Type	
		N/A	l		N/A
			Yes	Surface Condition? (G/P)	Good
			No	Curb Slope (%)	6.2

Remove & Replace Curb Ramp With Two New Directional Ramps or Equivalent.
