Intersection ID: 44463	Main Street: BUCKHORN_ST	Cross Street: VALCOURT_RD	Location:	NW
ADA ID: 893C23B2153C	Ramp Type: PerpDiag	Initial Pass/Fail: Fail	Overall Compliance: No	Severity Score: 21.25

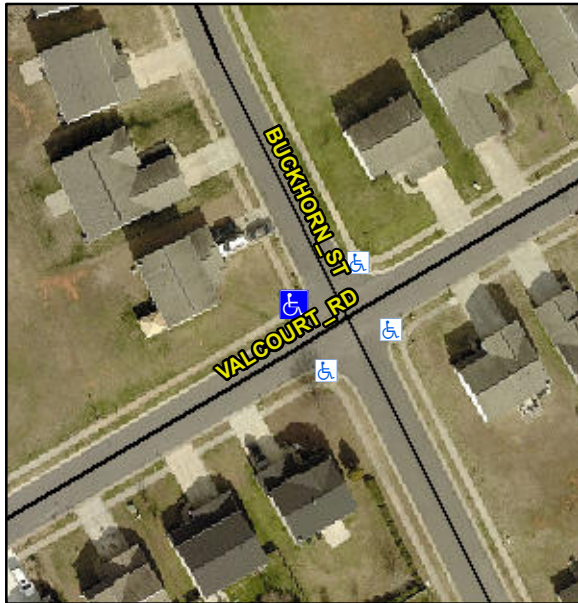
### R304.5.1, R304.2.2

Compliance	Description	Data	Compliance	Description	Data
N/A	Ramp Length (in)	50.5	No	Ramp Slope (%)	9.1
No	Ramp Width (in)	38.5	Yes	Ramp XSlope (%)	1.6
N/A	Flare Type LT	N/A	N/A	Flare Type RT	N/A
N/A	Flare Slope LT (%)	N/A	N/A	Flare Slope RT (%)	N/A
N/A	Flare Traversable LT?	N/A	N/A	Flare Traversable RT?	N/A
N/A	Landing Length (in)	N/A	N/A	DWS Provided?	N/A
N/A	Landing Width (in)	N/A	N/A	DWS Contrast?	N/A
N/A	Landing Slope (%)	N/A	N/A	DWS Length (in)	N/A
N/A	Landing X Slope (%)	N/A	N/A	DWS Full Width?	N/A
N/A	Landing Curb? (Y/N)	N/A	N/A	DWS Offset (in)	N/A
N/A	Shared Landing?	N/A			
N/A	Gutter Ponding?	N/A	N/A	Gutter Slope (%)	N/A
N/A	Gutter Lip Ht (in)	N/A	N/A	Gutter X Slope (%)	N/A
N/A	Painted X Walk1?	No	N/A	Painted X Walk2?	No
	X Walk 1 Direction	To S		X Walk 2 Direction	To E
N/A	X Walk 1 Width (in)	N/A	N/A	X Walk 2 Width (in)	N/A
	X Walk 1 Slope (%)	5.9		X Walk 2 Slope (%)	1.5
	X Walk 1 X Slope (%)	1.2		X Walk 2 X Slope (%)	2.6

N/A	Ramp inside XWalk1?	N/A	N/A	Ramp inside XWalk2?	N/A
	Road Slope (%)	0.9	N/A	Clear Space?	N/A
	Road X Slope (%)	4.0	N/A	Clear Space to XWalk (in)	N/A
N/A	Any Obstructions?	N/A	N/A	Storm Grate/Utility Hazard?	N/A
	Obstruction Type			Storm Grate/Utility Type	
		N/A			N/A
			Yes	Surface Condition? (G/P)	Good

**Remove & Replace Curb Ramp With Two New Directional Ramps or Equivalent.**

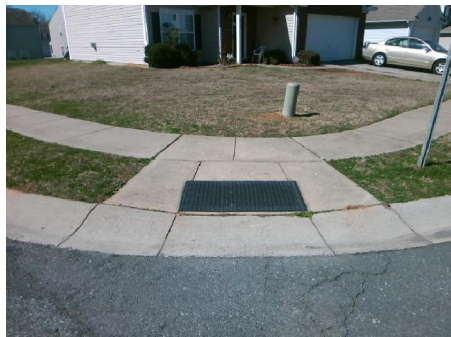
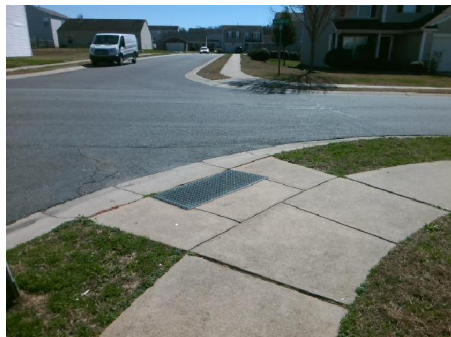
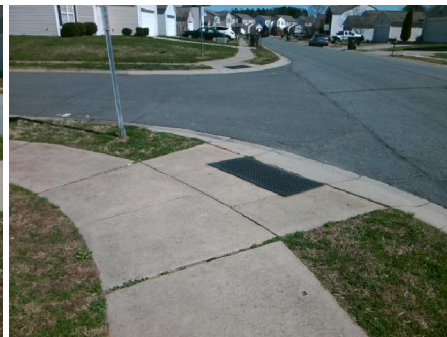
Street 1 Name	VALCOURT RD
Stop Condition-Street 2	None
Street 2 Name	BUCKHORN ST
Stop Condition-Street 1	StopSign
