# Access Compliance Report

## Public Rights-of-Way

### (Curb Ramps)

| Intersection ID: 16600 | Main Street: HARTFORD_AV | Cross Street: SHAWNEE_DR | Location: NW |

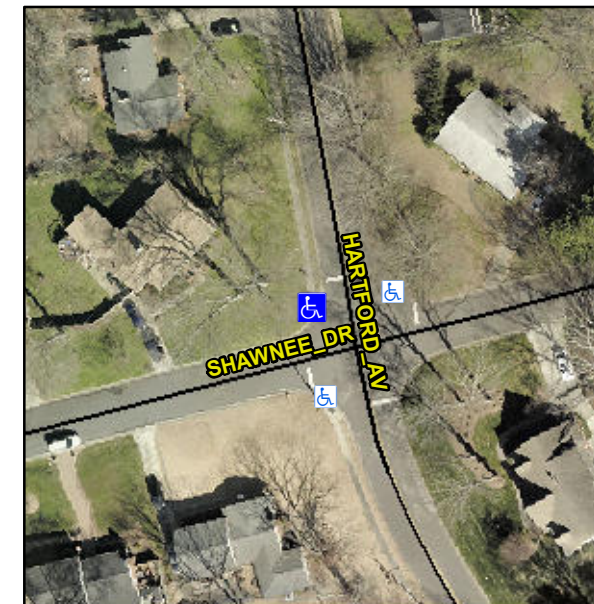
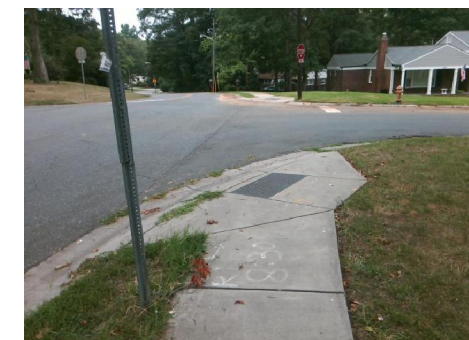
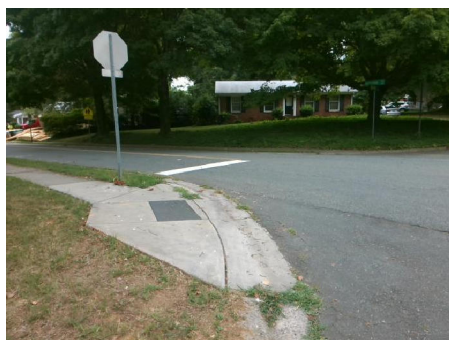
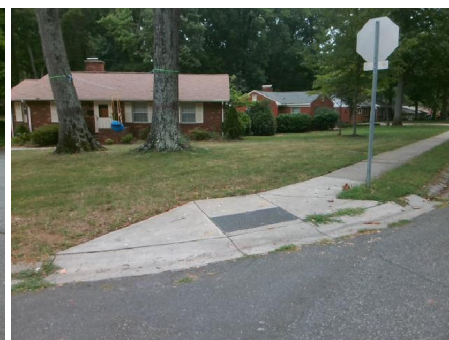
| ADA ID: 893D1C207CCB | Ramp Type: PerpDiag | Initial Pass/Fail: Fail | Overall Compliance: No |
| | | Severity Score: 1.25 | |

**Not Found, R304.5.3**

| Compliance | Description | Data | Compliance | Description | Data |
|---|---|---|---|---|---|
| Yes | Ramp Width (in) | 48.0 | No | Ramp XSlope (%) | 2.9 |

**Remove & Replace Curb Ramp With Two New Directional Ramps or Equivalent.**

Total Cost: \$ 3200.00
