## **Access Compliance Report Public Rights-of-Way** (Curb Ramps)

Intersection ID: 15402 **Cross Street: NEW BERN ST** Location: Main Street: MARSH RD N

ADA ID: 8958D6257CC0 Ramp Type: Perp Initial Pass/Fail: Fail **Overall Compliance: No** Severity Score: 13.75

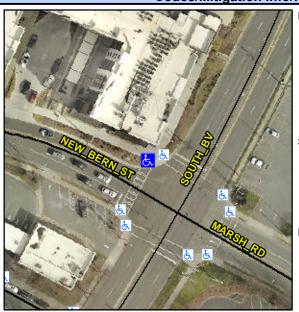
Possible Solutions: Compliance Description Remove & Replace Entire Ramp. Surveyor Notes: N/A PROW/ADA: Not Found, R304.2.2, R304.5.3
