Access Compliance Report

Public Rights-of-Way

(Curb Ramps)

Intersection ID: N/A	Main Street: MCCLINTOCK_RD	Cross Street: N/A	Location: SW
ADA ID: 896E4B108DFD	Ramp Type: Combination1	Initial Pass/Fail: Fail	Overall Compliance: No
			Severity Score: 13.75

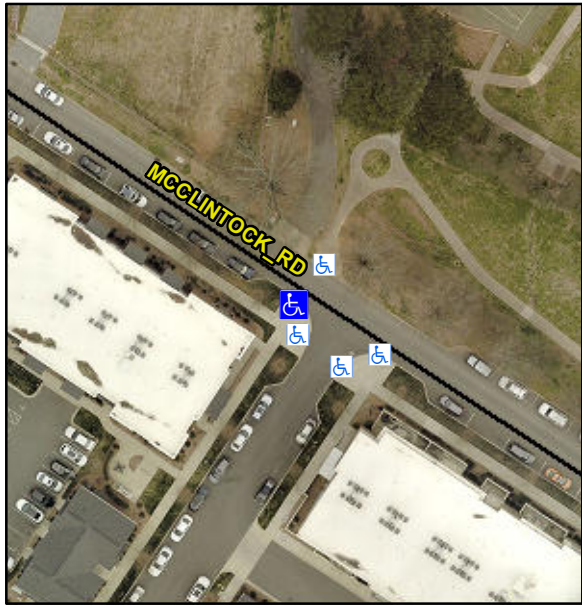
Possible Solutions:			Compliance	Description	Data	Compliance	Description	Data
	Remove & Replace Entire Ramp.			N/A	Ramp Length LT (in)	34.0	N/A	Ramp Length RT (in)	74.0
				Yes	Ramp Width LT (in)	64.0	Yes	Ramp Width RT (in)	61.0
				Yes	Ramp Slope LT (%)	3.2	No	Ramp Slope RT (%)	8.9
				Yes	Ramp XSlope LT (%)	1.4	No	Ramp XSlope RT (%)	2.6
				N/A	Ramp Length (in)	29.0	Yes	Ramp Slope (%)	5.4
				Yes	Ramp Width (in)	48.0	Yes	Ramp XSlope (%)	2.0
				N/A	Flare Type LT	N/A	N/A	Flare Type RT	N/A
				N/A	Flare Slope LT (%)	N/A	N/A	Flare Slope RT (%)	N/A
				N/A	Flare Traversable LT?	N/A	N/A	Flare Traversable RT?	N/A
Surveyor Notes: LT RP < 5% PROW/ADA: R304.3.2, R304.5.3			N/A	Landing Length (in)	N/A	N/A	DWS Provided?	N/A	
			N/A	Landing Width (in)	N/A	N/A	DWS Contrast?	N/A	
			N/A	Landing Slope (%)	N/A	N/A	DWS Length (in)	N/A

N/A	Landing X Slope (%)	N/A	N/A	DWS Full Width?	N/A	
			N/A	Landing Curb? (Y/N)	N/A	N/A	DWS Offset (in)	N/A	
			N/A	Shared Landing?	N/A	N/A			
			N/A	Gutter Ponding?	N/A	N/A	Gutter Slope (%)	N/A	
			N/A	Gutter Lip Ht (in)	N/A	N/A	Gutter X Slope (%)	N/A	
			N/A	Painted X Walk1?	No	N/A	Painted X Walk2?	N/A	
							X Walk 1 Direction	To NE	
				X Walk 1 Width (in)	N/A		X Walk 2 Width (in)	N/A	
				X Walk 1 Slope (%)	2.5		X Walk 2 Slope (%)	N/A	
				X Walk 1 X Slope (%)	2.3		X Walk 2 X Slope (%)	N/A	
			N/A	Ramp inside XWalk1?	N/A	N/A	Ramp inside XWalk2?	N/A	
				Road Slope (%)	N/A		Clear Space?	N/A	
				Road X Slope (%)	N/A	N/A	Clear Space to XWalk (in)	N/A	
						N/A	Any Obstruction?	N/A	
							Obstruction Type	N/A	
								N/A	
						N/A	Storm Grate/Utility Hazard?	N/A	
							Storm Grate/Utility Type	N/A	
								N/A	
						Yes	Surface Condition? (G/P)	Good	
							Curb Slope (%)	2.1
