Access Compliance Report

Public Rights-of-Way

(Curb Ramps)

Intersection ID: N/A	Main Street: BLYTHNE_BV	Cross Street: N/A	Location: SE
ADA ID: 896EAAD0C8E7	Ramp Type: Perp	Initial Pass/Fail: Fail	Overall Compliance: No
		Severity Score: 50

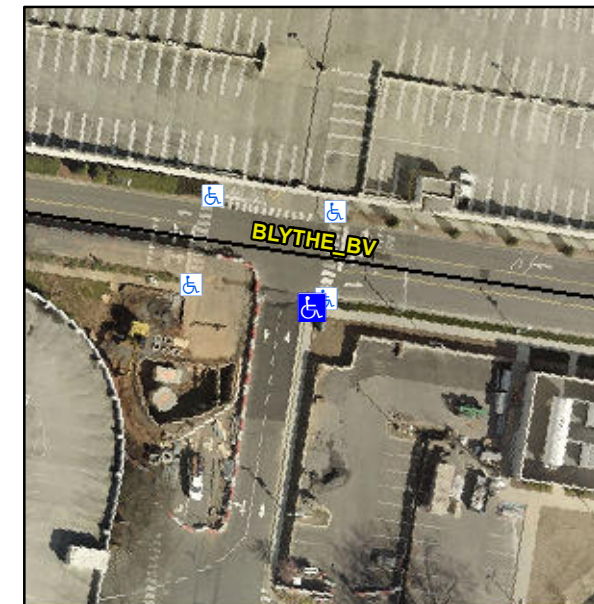
Not Found, R304.2.2, R304.5.3

Compliance	Description	Data	Compliance	Description	Data
N/A	Ramp Length (in)	55.0	No	Ramp Slope (%)	12.3
Yes	Ramp Width (in)	48.0	No	Ramp XSlope (%)	7.5
N/A	Flare Type LT	N/A	N/A	Flare Type RT	N/A
N/A	Flare Slope LT (%)	N/A	N/A	Flare Slope RT (%)	N/A
N/A	Flare Traversable LT?	N/A	N/A	Flare Traversable RT?	N/A
N/A	Landing Length (in)	N/A	N/A	DWS Provided?	N/A
N/A	Landing Width (in)	N/A	N/A	DWS Contrast?	N/A
N/A	Landing Slope (%)	N/A	N/A	DWS Length (in)	N/A
N/A	Landing X Slope (%)	N/A	N/A	DWS Full Width?	N/A
N/A	Landing Curb? (Y/N)	N/A	N/A	DWS Offset (in)	N/A
N/A	Shared Landing?	N/A			
N/A	Gutter Ponding?	N/A	N/A	Gutter Slope (%)	N/A
N/A	Gutter Lip Ht (in)	N/A	N/A	Gutter X Slope (%)	N/A
N/A	Painted X Walk1?	Yes	N/A	Painted X Walk2?	N/A
	X Walk 1 Direction	To NW		X Walk 2 Direction	N/A
N/A	X Walk 1 Width (in)	64.0	N/A	X Walk 2 Width (in)	N/A
	X Walk 1 Slope (%)	0.8		X Walk 2 Slope (%)	N/A
	X Walk 1 X Slope (%)	4.0		X Walk 2 X Slope (%)	N/A

N/A	Ramp inside XWalk1?	Yes	N/A	Ramp inside XWalk2?	N/A
	Road Slope (%)	N/A	N/A	Clear Space?	N/A
	Road X Slope (%)	N/A	N/A	Clear Space to XWalk (in)	N/A
N/A	Any Obstructions?	N/A	N/A	Storm Grate/Utility Hazard?	N/A
	Obstruction Type			Storm Grate/Utility Type	
		N/A			N/A
			Yes	Surface Condition? (G/P)	Good

Remove & Replace Entire Ramp.
