## Access Compliance Report Public Rights-of-Way (Curb Ramps)

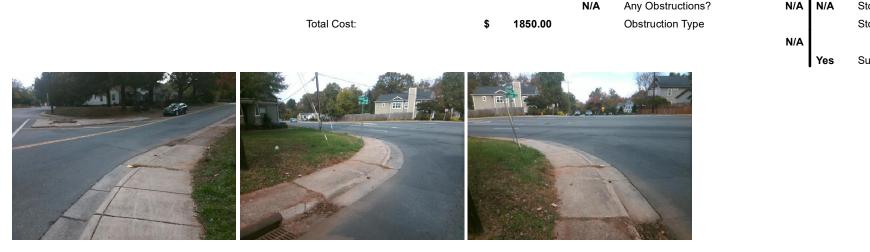
Intersection ID: 10795	Main Street: CLEMSON_AV			Cross Street: MATHESON_AV				Location: S	
ADA ID: 897E119B7765	Ramp Type: Perp			Initial Pass/Fail: Fail Overall Compliance:			ice: No	Severity Score:	10
Codes/Mitigation Info/Possible Solution				Field Measurements/Component Compliance					
	· · · ·	Possible Solutions:		Compliance Description Data			Compliance Description		Data
	D F	Remove & Replace Entire Ram	).	N/A	Ramp Length (in)	59.5	Yes	Ramp Slope (%)	7.6
La Carlo Car				No	Ramp Width (in)	44.0	No	Ramp XSlope (%)	2.7
	WESLE	1		N/A	Flare Type LT	N/A	N/A	Flare Type RT	N/A
Most	and the second			N/A	Flare Slope LT (%)	N/A	N/A	Flare Slope RT (%)	N/A
MATCHESON AV				N/A	Flare Traversable LT?	N/A	N/A	Flare Traversable RT?	N/A
				N/A	Landing Length (in)	N/A	N/A	DWS Provided?	N/A
6		Surveyor Notes:		N/A	Landing Width (in)	N/A	N/A	DWS Contrast?	N/A
the second secon	C	N/A		N/A	Landing Slope (%)	N/A	N/A	DWS Length (in)	N/A

5			N/A	Landing X Slope (%)	N/A	N/A	DWS Full Width?	N/A
Contraction of 182				N/A	Landing Curb? (Y/N)	N/A	N/A	DWS Offset (in)	N/A
	1. Constant			N/A	Shared Landing?	N/A			
		PROW/ADA:		N/A	Gutter Ponding?	N/A	N/A	Gutter Slope (%)	N/A
	Ar. A.	Not Found, R304.5.1, R304.5.3		N/A	Gutter Lip Ht (in)	1.0	N/A	Gutter X Slope (%)	N/A
The second of the second	- 200 1/20			N/A	Painted X Walk1?	No	N/A	Painted X Walk2?	N/A
A State State State	11 2 44				X Walk 1 Direction	To NE		X Walk 2 Direction	N/A
INI INI	1 Lates			N/A	X Walk 1 Width (in)	N/A	N/A	X Walk 2 Width (in)	N/A
Street 1 Name	CLEMSON AV				X Walk 1 Slope (%)	5.9		X Walk 2 Slope (%)	N/A
Stop Condition-Street 2	None				X Walk 1 X Slope (%)	1.7		X Walk 2 X Slope (%)	N/A
Street 2 Name	N/A			N/A	Ramp inside XWalk1?	N/A	N/A	Ramp inside XWalk2?	N/A
Stop Condition-Street 1	N/A				Road Slope (%)	N/A	N/A	Clear Space?	N/A
					Road X Slope (%)	N/A	N/A	Clear Space to XWalk (in)	N/A

N/A	Any Obstructions?	N/A	N/A	Storm Grate/Utility Hazard?	N/A
		Total Cost: \$	1850.00		Obstruction Type			Storm Grate/Utility Type	
						N/A			N/A
