Access Compliance Report Public Rights-of-Way (Curb Ramps)

Intersection ID: 15247Main Street: E_INDEPENDENCE_BVCross Street: EASTWAY_DR_RALocation:NADA ID: 8991BC9F91F0Ramp Type: PerpInitial Pass/Fail: FailOverall Compliance: NoSeverity Score:10

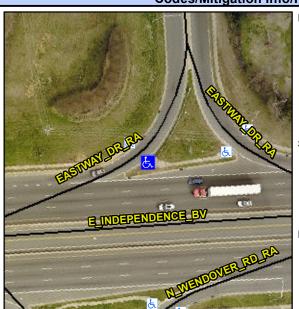
Fleid Measurements/Component Compilance							
Compliance Description		Data	Compliance Description		Data		
N/A	Ramp Length (in)	68.0	Yes	Ramp Slope (%)	7.0		
No	Ramp Width (in)	43.5	No	Ramp XSlope (%)	2.1		
N/A	Flare Type LT	N/A	N/A	Flare Type RT	N/A		
N/A	Flare Slope LT (%)	N/A	N/A	Flare Slope RT (%)	N/A		
N/A	Flare Traversable LT?	N/A	N/A	Flare Traversable RT?	N/A		
N/A	Landing Length (in)	N/A	N/A	DWS Provided?	N/A		
N/A	Landing Width (in)	N/A	N/A	DWS Contrast?	N/A		
N/A	Landing Slope (%)	N/A	N/A	DWS Length (in)	N/A		
N/A	Landing X Slope (%)	N/A	N/A	DWS Full Width?	N/A		
N/A	Landing Curb? (Y/N)	N/A	N/A	DWS Offset (in)	N/A		
N/A	Shared Landing?	N/A					
N/A	Gutter Ponding?	N/A	N/A	Gutter Slope (%)	N/A		
N/A	Gutter Lip Ht (in)	N/A	N/A	Gutter X Slope (%)	N/A		
N/A	Painted X Walk1?	No	N/A	Painted X Walk2?	N/A		
	X Walk 1 Direction	To NW		X Walk 2 Direction	N/A		
N/A	X Walk 1 Width (in)	N/A	N/A	X Walk 2 Width (in)	N/A

X Walk 1 Slope (%)	6.1		X Walk 2 Slope (%)	N/A		
	X Walk 1 X Slope (%)	1.0		X Walk 2 X Slope (%)	N/A		
N/A	Ramp inside XWalk1?	N/A	N/A	Ramp inside XWalk2?	N/A		
	Road Slope (%)	N/A	N/A	Clear Space?	N/A		
	Road X Slope (%)	N/A	N/A	Clear Space to XWalk (in)	N/A		
N/A	Any Obstructions?	N/A	N/A	Storm Grate/Utility Hazard?	N/A		
	Obstruction Type			Storm Grate/Utility Type			
		N/A			N/A		
			Yes	Surface Condition? (G/P)	Good

Possible Solutions:	9
Remove & Replace Entire Ramp.	ı
	ı
	ı
	I
	I
	I
Surveyor Notes:	I
N/A	I
	I
	I
	ı
PROW/ADA:	I
Not Found, R304.5.1, R304.5.3	ı
	I
	_
	ı
	ı
