Access Compliance Report

Public Rights-of-Way

(Curb Ramps)

Intersection ID: 31894	Main Street: GREEN_MOUNTAIN_RD	Cross Street: MOUNTAIN_SPRINGS_DR	Location: SW
ADA ID: 89A02BB60952	Ramp Type: PerpDiag	Initial Pass/Fail: Fail	Overall Compliance: No
Severity Score: 22.5			
Codes/Mitigation Info/Possible Solution		Field Measurements/Component Compliance

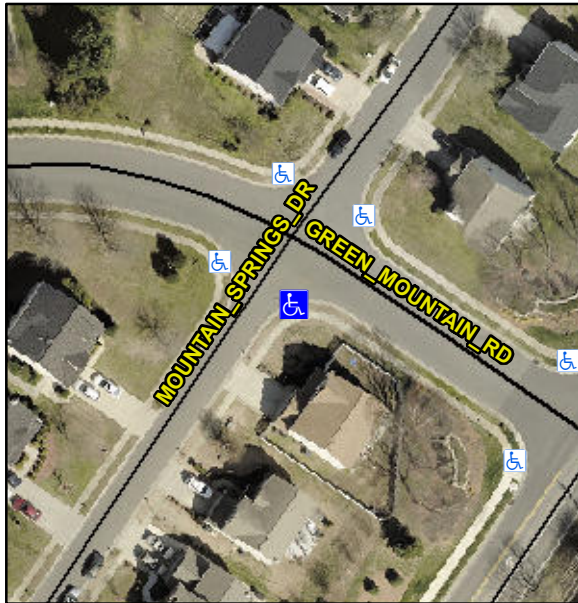
Compliance	Description	Data	Compliance	Description	Data
N/A	Ramp Length (in)	46.0	No	Ramp Slope (%)	10.0
No	Ramp Width (in)	39.0	No	Ramp XSlope (%)	3.0
N/A	Flare Type LT	N/A	N/A	Flare Type RT	N/A
N/A	Flare Slope LT (%)	N/A	N/A	Flare Slope RT (%)	N/A
N/A	Flare Traversable LT?	N/A	N/A	Flare Traversable RT?	N/A
N/A	Landing Length (in)	N/A	N/A	DWS Provided?	N/A
N/A	Landing Width (in)	N/A	N/A	DWS Contrast?	N/A
N/A	Landing Slope (%)	N/A	N/A	DWS Length (in)	N/A
N/A	Landing X Slope (%)	N/A	N/A	DWS Full Width?	N/A
N/A	Landing Curb? (Y/N)	N/A	N/A	DWS Offset (in)	N/A
N/A	Shared Landing?	N/A			
N/A	Gutter Ponding?	N/A	N/A	Gutter Slope (%)	N/A
N/A	Gutter Lip Ht (in)	N/A	N/A	Gutter X Slope (%)	N/A
N/A	Painted X Walk1?	No	N/A	Painted X Walk2?	No
	X Walk 1 Direction	To NE		X Walk 2 Direction	To NW
N/A	X Walk 1 Width (in)	N/A	N/A	X Walk 2 Width (in)	N/A
	X Walk 1 Slope (%)	0.4		X Walk 2 Slope (%)	4.1
	X Walk 1 X Slope (%)	4.6		X Walk 2 X Slope (%)	0.6

N/A	Ramp inside XWalk1?	N/A	N/A	Ramp inside XWalk2?	N/A
	Road Slope (%)	2.1	N/A	Clear Space?	N/A
	Road X Slope (%)	4.6	N/A	Clear Space to XWalk (in)	N/A
N/A	Any Obstructions?	N/A	N/A	Storm Grate/Utility Hazard?	N/A
	Obstruction Type			Storm Grate/Utility Type	
		N/A			N/A
			Yes	Surface Condition? (G/P)	Good

Possible Solutions:

Remove & Replace Curb Ramp With Two New Directional Ramps or Equivalent.
