Access Compliance Report Public Rights-of-Way (Curb Ramps)

Intersection ID: 42740 Main Street: CALDWELL_RIDGE_PY Cross Street: DANIEL_PLACE_DR Location: NW

ADA ID: 89A7B1627B92 Ramp Type: PerpDiag Initial Pass/Fail: Pass Overall Compliance: No Severity Score: 21.75

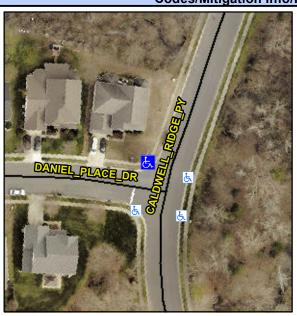
PROW/ADA:
Not Found, R304.5.3, R304.2.1,
R305, R302.7.2

Field Measurements/Component Compliance					
Compliance Description Da		Data	Comp	oliance Description	Data
N/A	Ramp Length (in)	45.0	Yes	Ramp Slope (%)	6.1
Yes	Ramp Width (in)	52.0	No	Ramp XSlope (%)	3.7
N/A	Flare Type LT	Sloped	N/A	Flare Type RT	N/A
N/A	Flare Slope LT (%)	6.5	Yes	Flare Slope RT (%)	1.0
N/A	Flare Traversable LT?	Yes	N/A	Flare Traversable RT?	Yes
No	Landing Length (in)	47.0	No	DWS Provided?	No
No	Landing Width (in)	44.0	N/A	DWS Contrast?	No
Yes	Landing Slope (%)	1.0	N/A	DWS Length (in)	N/A
No	Landing X Slope (%)	4.7	N/A	DWS Full Width?	No
N/A	Landing Curb? (Y/N)	No	N/A	DWS Offset (in)	N/A
N/A	Shared Landing?	No			
Yes	Gutter Ponding?	No	Yes	Gutter Slope (%)	1.7
No	Gutter Lip Ht (in)	0.5	No	Gutter X Slope (%)	4.1
N/A	Painted X Walk1?	No	N/A	Painted X Walk2?	No
	X Walk 1 Direction	To SW		X Walk 2 Direction	To E
N/A	X Walk 1 Width (in)	N/A	N/A	X Walk 2 Width (in)	N/A
	X Walk 1 Slope (%)	3.6		X Walk 2 Slope (%)	0.2

X Walk 1 X Slope (%)	3.0		X Walk 2 X Slope (%)	2.2
N/A	Ramp inside XWalk1?	N/A	N/A	Ramp inside XWalk2?	N/A
	Road Slope (%)	1.2	N/A	Clear Space?	Yes
	Road X Slope (%)	1.9	N/A	Clear Space to XWalk (in)	N/A
Yes	Any Obstructions?	No	Yes	Storm Grate/Utility Hazard?	No
	Obstruction Type			Storm Grate/Utility Type	
		N/A			N/A
			Yes	Surface Condition? (G/P)	Good

DANIEL PLACE DR StopSign CALDWELL RIDGE PY None Possible Solutions:

Remove & Replace Curb Ramp With
Two New Directional Ramps or
Equivalent. Remove & Replace
Gutter.
