Access Compliance Report

Public Rights-of-Way

(Curb Ramps)

Intersection ID: 12669	Main Street: E_10TH_ST	Cross Street: STEVENS_ST	Location: S
ADA ID: 89B92132F4A2	Ramp Type: Combination1	Initial Pass/Fail: Fail	Overall Compliance: No
			Severity Score: 13.75

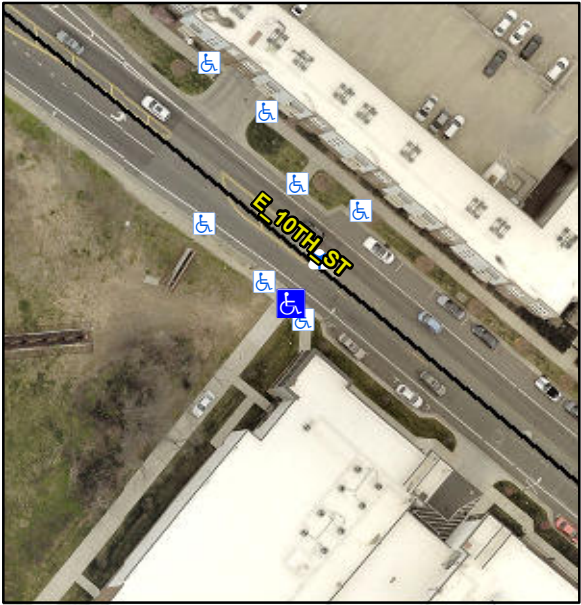
Possible Solutions:		Compliance	Description	Data	
	Remove & Replace Entire Ramp.		N/A	Ramp Length LT (in)	96.0	N/A
			Yes	Ramp Width LT (in)	84.0	Yes
			No	Ramp Slope LT (%)	9.7	Yes
			No	Ramp XSlope LT (%)	2.6	Yes
			N/A	Ramp Length (in)	83.0	Yes
			Yes	Ramp Width (in)	120.0	Yes
			N/A	Flare Type LT	N/A	N/A
			N/A	Flare Slope LT (%)	N/A	N/A
			N/A	Flare Traversable LT?	N/A	N/A
<p>Surveyor Notes:</p> <p>RT RP < 5%</p> <p>PROW/ADA:</p> <p>Not Found, R304.3.2, R304.5.3</p>			N/A	Ramp Slope RT (%)	1.6	Yes
			Yes	Ramp XSlope RT (%)	1.3	Yes
			N/A	Ramp Slope (%)	0.8	Yes
			Yes	Ramp XSlope (%)	4.9	Yes
			N/A	Flare Type RT	N/A	N/A
			N/A	Flare Slope RT (%)	N/A	N/A
			N/A	Flare Traversable RT?	N/A	N/A
			N/A	DWS Provided?	N/A	N/A
			N/A	DWS Contrast?	N/A	N/A
			N/A	DWS Length (in)	N/A	N/A
<p>Total Cost:</p> <p>\$ 1800.00</p>			N/A	DWS Full Width?	N/A	N/A
