Access Compliance Report

Public Rights-of-Way

(Curb Ramps)

Intersection ID: 13029	Main Street: HAMORTON_PL	Cross Street: NASSAU_BV	Location: E
ADA ID: 89C648DA1D5D	Ramp Type: Perp	Initial Pass/Fail: Fail	Overall Compliance: No
			Severity Score: 21.25

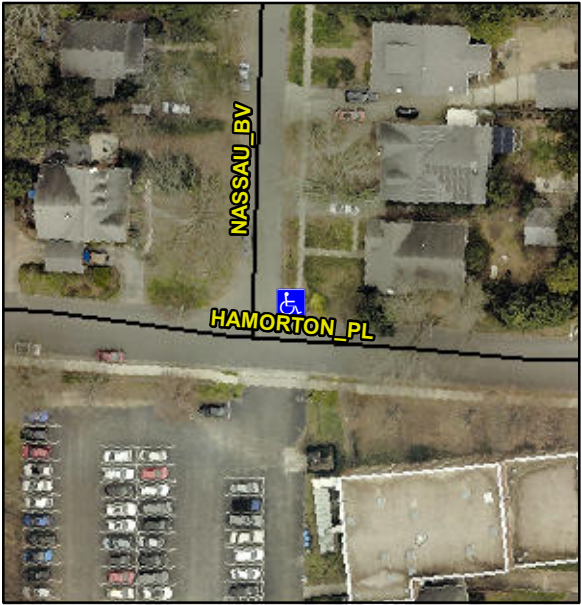
Possible Solutions:		Compliance	Description	Data
	Remove & Replace Entire Ramp.		No	Ramp Length (in)	76.0
			No	Ramp Width (in)	44.5
			N/A	Flare Type LT	N/A
			N/A	Flare Slope LT (%)	N/A
			N/A	Flare Traversable LT?	N/A
			N/A	Landing Length (in)	N/A
			N/A	Landing Width (in)	N/A
			N/A	Landing Slope (%)	N/A
			N/A	Landing X Slope (%)	N/A
<p>Surveyor Notes:</p> <p>N/A</p> <p>PROW/ADA:</p> <p>Not Found, R304.5.1, R304.2.2</p>			N/A	Landing Curb? (Y/N)	N/A
			N/A	Shared Landing?	N/A
			N/A	Gutter Ponding?	Yes
			N/A	Gutter Lip Ht (in)	0.5
			N/A	Painted X Walk1?	No
				X Walk 1 Direction	To S
			N/A	X Walk 1 Width (in)	N/A
				X Walk 1 Slope (%)	2.1
				X Walk 1 X Slope (%)	3.6
			N/A	Ramp inside XWalk1?	N/A
<p>Street 1 Name</p> <p>Stop Condition-Street 2</p> <p>Street 2 Name</p> <p>Stop Condition-Street 1</p>			N/A	Road Slope (%)	N/A
