Intersection ID: 14306	Main Street: HARRISBURG_RD	Cross Street: PARKTON_RD	Location:	SE
ADA ID: 89C66511F14D	Ramp Type: ParaDiag	Initial Pass/Fail: Fail	Overall Compliance: No	Severity Score: 26.25

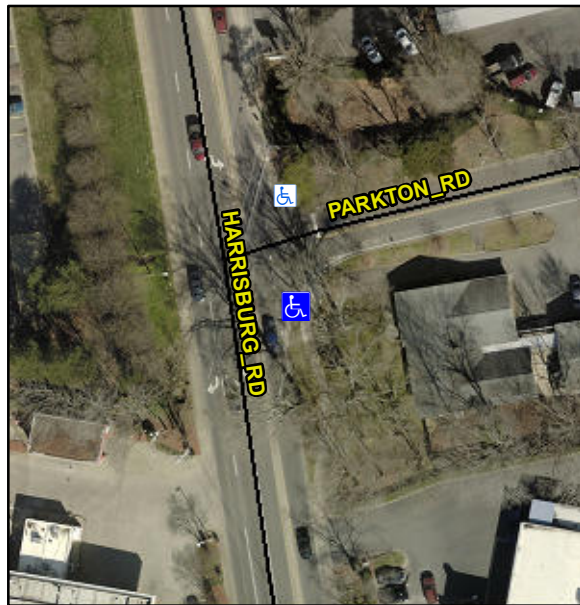
RT RP < 5%

R304.3.2, R304.5.3

Compliance	Description	Data	Compliance	Description	Data
N/A	Ramp Length LT (in)	60.0	N/A	Ramp Length RT (in)	57.0
Yes	Ramp Width LT (in)	59.0	Yes	Ramp Width RT (in)	60.0
No	Ramp Slope LT (%)	12.9	Yes	Ramp Slope RT (%)	4.4
No	Ramp XSlope LT (%)	4.5	Yes	Ramp XSlope RT (%)	0.2
N/A	Landing Length (in)	N/A	N/A	DWS Provided?	N/A
N/A	Landing Width (in)	N/A	N/A	DWS Contrast?	N/A
N/A	Landing Slope (%)	N/A	N/A	DWS Length (in)	N/A
N/A	Landing X Slope (%)	N/A	N/A	DWS Full Width?	N/A
N/A	Landing Curb? (Y/N)	N/A	N/A	DWS Offset (in)	N/A
N/A	Shared Landing?	N/A			
N/A	Gutter Ponding?	N/A	N/A	Gutter Slope (%)	N/A
N/A	Gutter Lip Ht (in)	N/A	N/A	Gutter X Slope (%)	N/A
N/A	Painted X Walk1?	No	N/A	Painted X Walk2?	No
	X Walk 1 Direction	To N		X Walk 2 Direction	To W
N/A	X Walk 1 Width (in)	N/A	N/A	X Walk 2 Width (in)	N/A
	X Walk 1 Slope (%)	3.7		X Walk 2 Slope (%)	2.9
	X Walk 1 X Slope (%)	5.4		X Walk 2 X Slope (%)	3.0
N/A	Ramp inside XWalk1?	N/A	N/A	Ramp inside XWalk2?	N/A

Road Slope (%)	3.7	N/A	Clear Space?	N/A
	Road X Slope (%)	0.7	N/A	Clear Space to XWalk (in)	N/A
N/A	Any Obstructions?	N/A	N/A	Storm Grate/Utility Hazard?	N/A
	Obstruction Type			Storm Grate/Utility Type	
		N/A			N/A
			Yes	Surface Condition? (G/P)	Good
			N/A	Curb Slope (%)	2.6

Possible Solutions:

Remove & Replace Curb Ramp With Two New Directional Ramps or Equivalent.
