Access Compliance Report

Public Rights-of-Way

(Curb Ramps)

Intersection ID: 10675	Main Street: HERRIN_AV	Cross Street: THE_PLAZA	Location:	E
ADA ID: 89C8D01DDD1A	Ramp Type: Perp	Initial Pass/Fail: Fail	Overall Compliance: No	Severity Score: 25

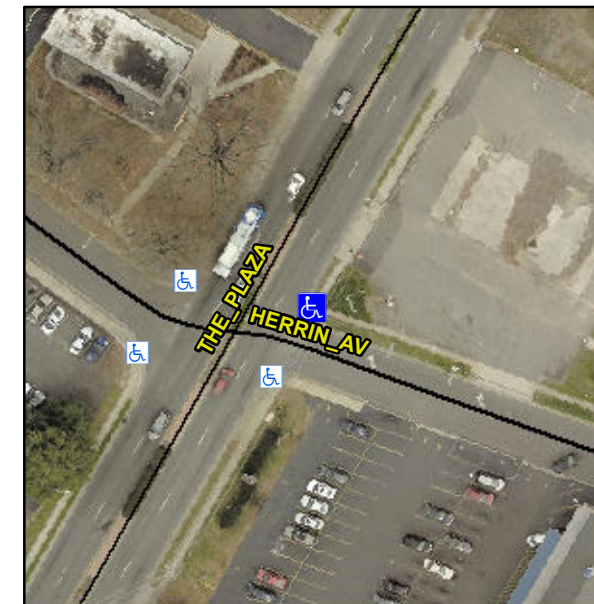
Not Found, R304.5.3

Compliance	Description	Data	Compliance	Description	Data
N/A	Ramp Length (in)	83.5	Yes	Ramp Slope (%)	5.0
Yes	Ramp Width (in)	87.0	No	Ramp XSlope (%)	9.2
N/A	Flare Type LT	N/A	N/A	Flare Type RT	N/A
N/A	Flare Slope LT (%)	N/A	N/A	Flare Slope RT (%)	N/A
N/A	Flare Traversable LT?	N/A	N/A	Flare Traversable RT?	N/A
N/A	Landing Length (in)	N/A	N/A	DWS Provided?	N/A
N/A	Landing Width (in)	N/A	N/A	DWS Contrast?	N/A
N/A	Landing Slope (%)	N/A	N/A	DWS Length (in)	N/A
N/A	Landing X Slope (%)	N/A	N/A	DWS Full Width?	N/A
N/A	Landing Curb? (Y/N)	N/A	N/A	DWS Offset (in)	N/A
N/A	Shared Landing?	N/A			
N/A	Gutter Ponding?	N/A	N/A	Gutter Slope (%)	N/A
N/A	Gutter Lip Ht (in)	N/A	N/A	Gutter X Slope (%)	N/A
N/A	Painted X Walk1?	No	N/A	Painted X Walk2?	N/A
	X Walk 1 Direction	To SW		X Walk 2 Direction	N/A
N/A	X Walk 1 Width (in)	N/A	N/A	X Walk 2 Width (in)	N/A
	X Walk 1 Slope (%)	1.1		X Walk 2 Slope (%)	N/A
	X Walk 1 X Slope (%)	3.0		X Walk 2 X Slope (%)	N/A

N/A	Ramp inside XWalk1?	N/A	N/A	Ramp inside XWalk2?	N/A
	Road Slope (%)	3.0	N/A	Clear Space?	N/A
	Road X Slope (%)	1.1	N/A	Clear Space to XWalk (in)	N/A
N/A	Any Obstructions?	N/A	N/A	Storm Grate/Utility Hazard?	N/A
	Obstruction Type			Storm Grate/Utility Type	
		N/A			N/A
			Yes	Surface Condition? (G/P)	Good

Remove & Replace Entire Ramp.
