# Access Compliance Report

## Public Rights-of-Way

### (Curb Ramps)

Intersection ID: 14851	Main Street: E_WORTHINGTON_AV	Cross Street: PARK_RD	Location: S
ADA ID: 89CBB5F302B8	Ramp Type: Perp	Initial Pass/Fail: Fail	Overall Compliance: No
Severity Score: 13.75			
Codes/Mitigation Info/Possible Solution		Field Measurements/Component Compliance

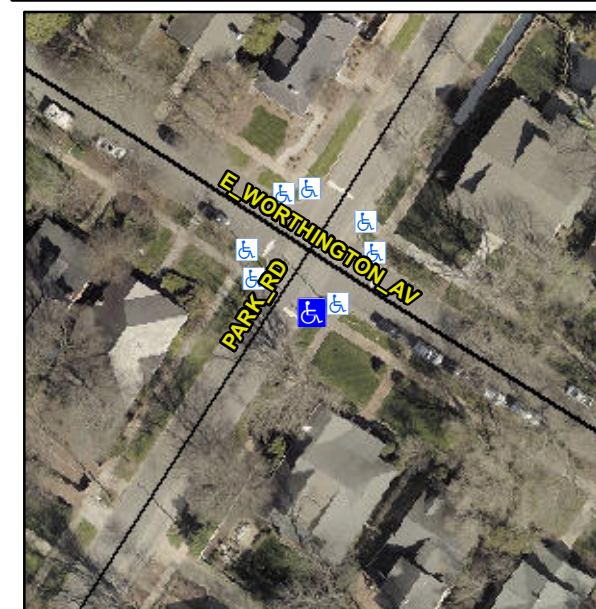
**Not Found, R304.2.2, R304.5.3**

Compliance	Description	Data	Compliance	Description	Data
N/A	Ramp Length (in)	50.0	No	Ramp Slope (%)	9.4
Yes	Ramp Width (in)	48.0	No	Ramp XSlope (%)	2.5
N/A	Flare Type LT	N/A	N/A	Flare Type RT	N/A
N/A	Flare Slope LT (%)	N/A	N/A	Flare Slope RT (%)	N/A
N/A	Flare Traversable LT?	N/A	N/A	Flare Traversable RT?	N/A
N/A	Landing Length (in)	N/A	N/A	DWS Provided?	N/A
N/A	Landing Width (in)	N/A	N/A	DWS Contrast?	N/A
N/A	Landing Slope (%)	N/A	N/A	DWS Length (in)	N/A
N/A	Landing X Slope (%)	N/A	N/A	DWS Full Width?	N/A
N/A	Landing Curb? (Y/N)	N/A	N/A	DWS Offset (in)	N/A
N/A	Shared Landing?	N/A			
N/A	Gutter Ponding?	N/A	N/A	Gutter Slope (%)	N/A
N/A	Gutter Lip Ht (in)	N/A	N/A	Gutter X Slope (%)	N/A
N/A	Painted X Walk1?	No	N/A	Painted X Walk2?	N/A
	X Walk 1 Direction	To NW		X Walk 2 Direction	N/A
N/A	X Walk 1 Width (in)	N/A	N/A	X Walk 2 Width (in)	N/A
	X Walk 1 Slope (%)	4.5		X Walk 2 Slope (%)	N/A
	X Walk 1 X Slope (%)	1.8		X Walk 2 X Slope (%)	N/A

N/A	Ramp inside XWalk1?	N/A	N/A	Ramp inside XWalk2?	N/A
	Road Slope (%)	N/A	N/A	Clear Space?	N/A
	Road X Slope (%)	N/A	N/A	Clear Space to XWalk (in)	N/A
N/A	Any Obstructions?	N/A	N/A	Storm Grate/Utility Hazard?	N/A
	Obstruction Type			Storm Grate/Utility Type	
		N/A			N/A
			Yes	Surface Condition? (G/P)	Good

Possible Solutions:

**Remove & Replace Entire Ramp.**

Total Cost: \$ 1850.00
