Access Compliance Report

Public Rights-of-Way

(Curb Ramps)

Intersection ID: 15725	Main Street: CLANTON_RD	Cross Street: S_TRYON_ST	Location: SE
ADA ID: 89CF86AF5EF1	Ramp Type: Perp	Initial Pass/Fail: Fail	Overall Compliance: No
Severity Score: 26.25			
Codes/Mitigation Info/Possible Solution		Field Measurements/Component Compliance

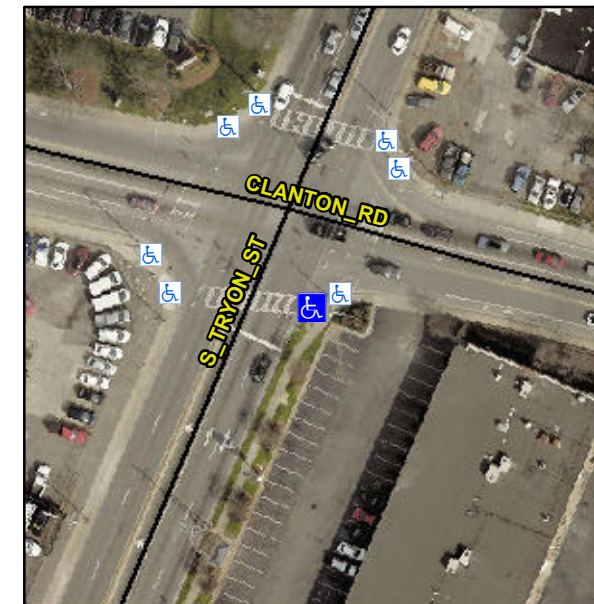
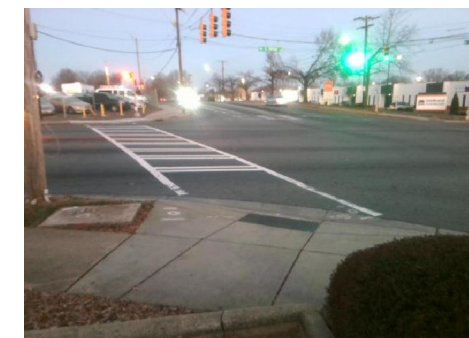
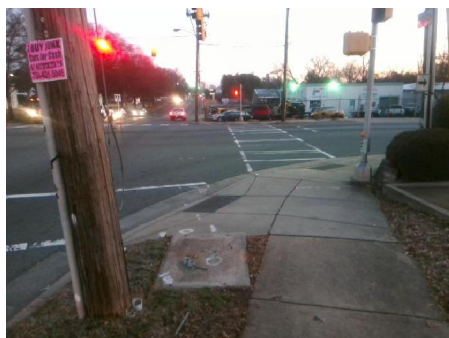
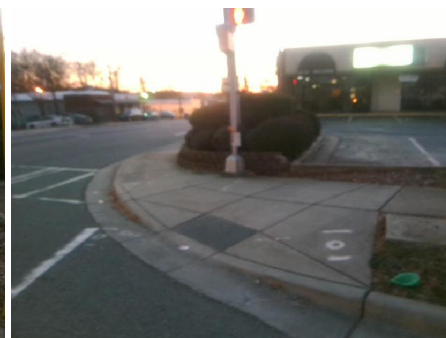
Not Found, R304.2.2, R304.5.3

Compliance	Description	Data	Compliance	Description	Data
N/A	Ramp Length (in)	60.0	No	Ramp Slope (%)	12.9
Yes	Ramp Width (in)	48.0	No	Ramp XSlope (%)	4.0
N/A	Flare Type LT	N/A	N/A	Flare Type RT	N/A
N/A	Flare Slope LT (%)	N/A	N/A	Flare Slope RT (%)	N/A
N/A	Flare Traversable LT?	N/A	N/A	Flare Traversable RT?	N/A
N/A	Landing Length (in)	N/A	N/A	DWS Provided?	N/A
N/A	Landing Width (in)	N/A	N/A	DWS Contrast?	N/A
N/A	Landing Slope (%)	N/A	N/A	DWS Length (in)	N/A
N/A	Landing X Slope (%)	N/A	N/A	DWS Full Width?	N/A
N/A	Landing Curb? (Y/N)	N/A	N/A	DWS Offset (in)	N/A
N/A	Shared Landing?	N/A			
N/A	Gutter Ponding?	N/A	N/A	Gutter Slope (%)	N/A
N/A	Gutter Lip Ht (in)	N/A	N/A	Gutter X Slope (%)	N/A
N/A	Painted X Walk1?	Yes	N/A	Painted X Walk2?	N/A
	X Walk 1 Direction	To W		X Walk 2 Direction	N/A
N/A	X Walk 1 Width (in)	102.0	N/A	X Walk 2 Width (in)	N/A
	X Walk 1 Slope (%)	2.3		X Walk 2 Slope (%)	N/A
	X Walk 1 X Slope (%)	1.1		X Walk 2 X Slope (%)	N/A

N/A	Ramp inside XWalk1?	Yes	N/A	Ramp inside XWalk2?	N/A
	Road Slope (%)	N/A	N/A	Clear Space?	N/A
	Road X Slope (%)	N/A	N/A	Clear Space to XWalk (in)	N/A
N/A	Any Obstructions?	N/A	N/A	Storm Grate/Utility Hazard?	N/A
	Obstruction Type			Storm Grate/Utility Type	
		N/A			N/A
		Yes		Surface Condition? (G/P)	Good

Remove & Replace Entire Ramp.

Total Cost: \$ 1850.00
