## **Access Compliance Report Public Rights-of-Way** (Curb Ramps)

Intersection ID: 11308 Main Street: CARDIFF AV **Cross Street: SPRINGWAY DR** Location: NW **Overall Compliance: No Severity Score:** ADA ID: 89D07689D75A Ramp Type: PerpDiag Initial Pass/Fail: Fail 55

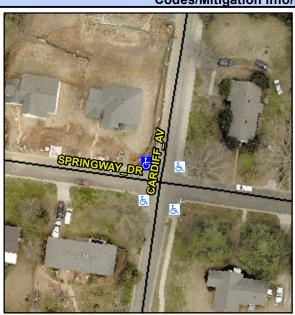
Total Cost: 3200.00 Compliance Description Data Compliance Description Data No Ramp Slope (%) N/A Ramp Length (in) 25.0 8.4 No Ramp XSlope (%) No Ramp Width (in) 35.5 9.6 N/A N/A Flare Type LT N/A Flare Type RT N/A N/A N/A N/A Flare Slope RT (%) N/A Flare Slope LT (%) N/A Flare Traversable LT? N/A N/A Flare Traversable RT? N/A N/A N/A N/A **DWS Provided?** N/A Landing Length (in) N/A Landing Width (in) N/A N/A **DWS Contrast?** N/A N/A N/A N/A Landing Slope (%) DWS Length (in) N/A N/A Landing X Slope (%) N/A N/A DWS Full Width? N/A N/A Landing Curb? (Y/N) N/A N/A DWS Offset (in) N/A N/A N/A Shared Landing? N/A **Gutter Ponding?** N/A N/A Gutter Slope (%) N/A N/A Gutter Lip Ht (in) N/A N/A Gutter X Slope (%) N/A N/A Painted X Walk1? No N/A Painted X Walk2? No X Walk 1 Direction To S X Walk 2 Direction To E N/A N/A X Walk 2 Width (in) X Walk 1 Width (in) N/A X Walk 1 Slope (%) 10.6 X Walk 2 Slope (%) 2.9 X Walk 1 X Slope (%) 3.6 X Walk 2 X Slope (%) 8.9 N/A N/A N/A Ramp inside XWalk2? N/A Ramp inside XWalk1? Road Slope (%) 6.6 N/A Clear Space? N/A N/A Road X Slope (%) 5.4 Clear Space to XWalk (in) N/A N/A N/A N/A Any Obstructions? Storm Grate/Utility Hazard? N/A **Obstruction Type** Storm Grate/Utility Type N/A N/A

Possible Solutions: Remove & Replace Curb Ramp With Two New Directional Ramps or Equivalent. Surveyor Notes: N/A PROW/ADA: Not Found, R304.5.1, R304.2.2, R304.5.3
