Access Compliance Report

Public Rights-of-Way

(Curb Ramps)

Intersection ID: N/A	Main Street: YORK_CENTER	Cross Street: N/A	Location: SE
ADA ID: 89D2C24EF2B3	Ramp Type: Perp	Initial Pass/Fail: Fail	Overall Compliance: No
Severity Score: 10			
Codes/Mitigation Info/Possible Solution		Field Measurements/Component Compliance

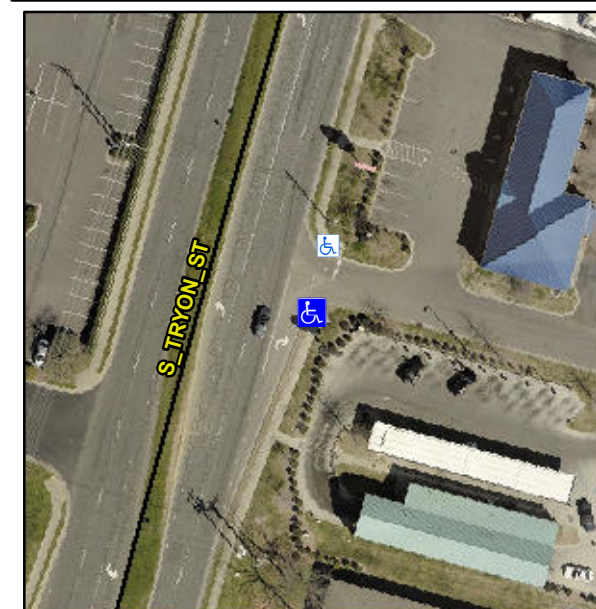
Not Found, R304.5.1, R304.5.3

Compliance	Description	Data	Compliance	Description	Data
N/A	Ramp Length (in)	91.0	Yes	Ramp Slope (%)	6.8
No	Ramp Width (in)	47.0	No	Ramp XSlope (%)	2.9
N/A	Flare Type LT	N/A	N/A	Flare Type RT	N/A
N/A	Flare Slope LT (%)	N/A	N/A	Flare Slope RT (%)	N/A
N/A	Flare Traversable LT?	N/A	N/A	Flare Traversable RT?	N/A
N/A	Landing Length (in)	N/A	N/A	DWS Provided?	N/A
N/A	Landing Width (in)	N/A	N/A	DWS Contrast?	N/A
N/A	Landing Slope (%)	N/A	N/A	DWS Length (in)	N/A
N/A	Landing X Slope (%)	N/A	N/A	DWS Full Width?	N/A
N/A	Landing Curb? (Y/N)	N/A	N/A	DWS Offset (in)	N/A
N/A	Shared Landing?	N/A			
N/A	Gutter Ponding?	N/A	N/A	Gutter Slope (%)	N/A
N/A	Gutter Lip Ht (in)	N/A	N/A	Gutter X Slope (%)	N/A
N/A	Painted X Walk1?	Yes	N/A	Painted X Walk2?	N/A
	X Walk 1 Direction	To N		X Walk 2 Direction	N/A
N/A	X Walk 1 Width (in)	54.0	N/A	X Walk 2 Width (in)	N/A
	X Walk 1 Slope (%)	0.5		X Walk 2 Slope (%)	N/A
	X Walk 1 X Slope (%)	2.4		X Walk 2 X Slope (%)	N/A

N/A	Ramp inside XWalk1?	No	N/A	Ramp inside XWalk2?	N/A
	Road Slope (%)	N/A	N/A	Clear Space?	N/A
	Road X Slope (%)	N/A	N/A	Clear Space to XWalk (in)	N/A
N/A	Any Obstructions?	N/A	N/A	Storm Grate/Utility Hazard?	N/A
	Obstruction Type			Storm Grate/Utility Type	
		N/A			N/A
			Yes	Surface Condition? (G/P)	Good

Possible Solutions:

**Remove & Replace Entire Ramp.
Restripe Crosswalk.**
