Access Compliance Report

Public Rights-of-Way

(Curb Ramps)

Intersection ID: 23563	Main Street: HILLSIDE_LN	Cross Street: REA_RD	Location: S
ADA ID: 89D466019023	Ramp Type: PerpDiag	Initial Pass/Fail: Fail	Overall Compliance: No
			Severity Score: 13.75

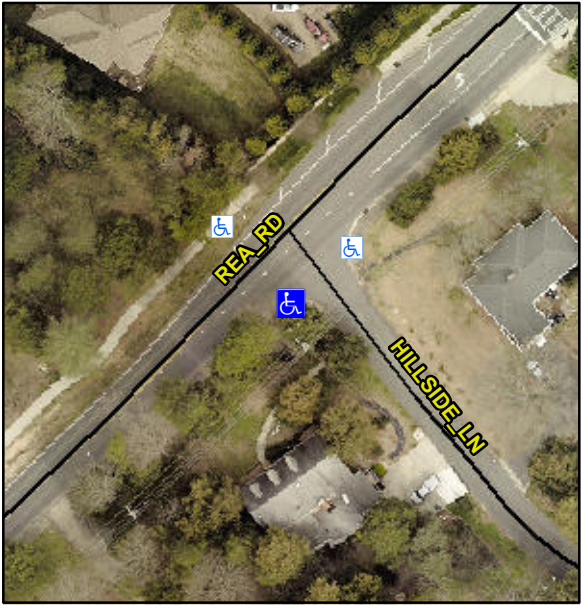
Possible Solutions:		Compliance	Description	Data
	Remove & Replace Curb Ramp With Two New Directional Ramps or Equivalent.		No	Ramp Length (in)	60.0
			Yes	Ramp Width (in)	48.0
			N/A	Flare Type LT	N/A
			N/A	Flare Slope LT (%)	N/A
			N/A	Flare Traversable LT?	N/A
			N/A	Landing Length (in)	N/A
			N/A	Landing Width (in)	N/A
			N/A	Landing Slope (%)	N/A
			N/A	Landing X Slope (%)	N/A
<p>Surveyor Notes:</p> <p>N/A</p> <p>PROW/ADA:</p> <p>Not Found, R304.2.2, R304.5.3</p>			N/A	Flare Type RT	N/A
			N/A	Flare Slope RT (%)	N/A
			N/A	Flare Traversable RT?	N/A
			N/A	DWS Provided?	N/A
			N/A	DWS Contrast?	N/A
			N/A	DWS Length (in)	N/A
			N/A	DWS Full Width?	N/A
			N/A	DWS Offset (in)	N/A
			N/A	Gutter Ponding?	N/A
			N/A	Gutter Lip Ht (in)	N/A
<p>Total Cost:</p> <p>\$ 3200.00</p>			No	Painted X Walk2?	No
			To NE	X Walk 2 Direction	To NW

N/A	X Walk 2 Width (in)	N/A
			6.9	X Walk 2 Slope (%)	2.0
			0.4	X Walk 2 X Slope (%)	5.2
			N/A	Ramp inside XWalk2?	N/A
			4.2	Clear Space?	N/A
			4.3	Clear Space to XWalk (in)	N/A
			N/A	Storm Grate/Utility Hazard?	N/A
			N/A	Storm Grate/Utility Type	N/A
<p>Obstruction Type</p> <p>N/A</p>			N/A	Surface Condition? (G/P)	Good
