Access Compliance Report

Public Rights-of-Way (Curb Ramps)

| Intersection ID: 4810 | Main Street: BEN_CRAIG_DR | Cross Street: MALLARD_CREEK_RD | Location: W |
| ADA ID: 8A08941769C9 | Ramp Type: Perp | Initial Pass/Fail: Fail | Overall Compliance: No |

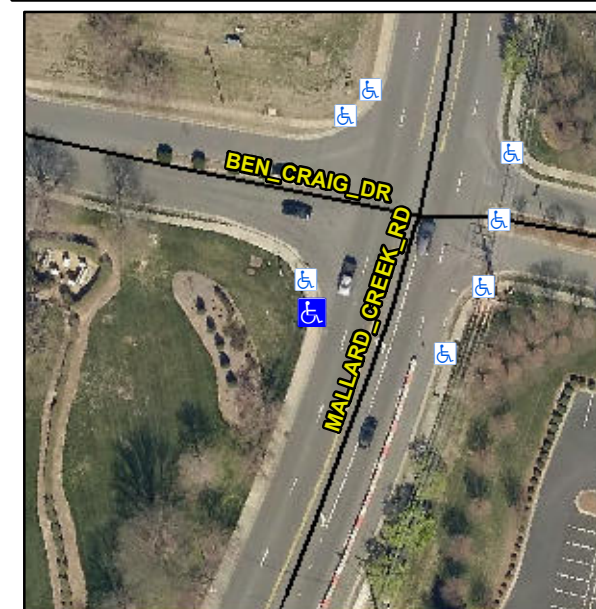
| Severity Score: 22.5 | | | |

Not Found, R304.5.1, R304.2.2

| Compliance | Description | Data | Compliance | Description | Data |
|---|---|---|---|---|---|
| N/A | Ramp Length (in) | 61.5 | No | Ramp Slope (%) | 9.5 |
| No | Ramp Width (in) | 41.0 | Yes | Ramp XSlope (%) | 4.4 |

Remove & Replace Entire Ramp.

Total Cost: \$ 1850.00
