# Access Compliance Report

## Public Rights-of-Way

### (Curb Ramps)

Intersection ID: 52452	Main Street: PAT_GARRETT_ST	Cross Street: BENDING_BIRCH_PL	Location: SE
ADA ID: 8A2915119D0C	Ramp Type: Directional1	Initial Pass/Fail: Fail	Overall Compliance: No
		Severity Score: 25

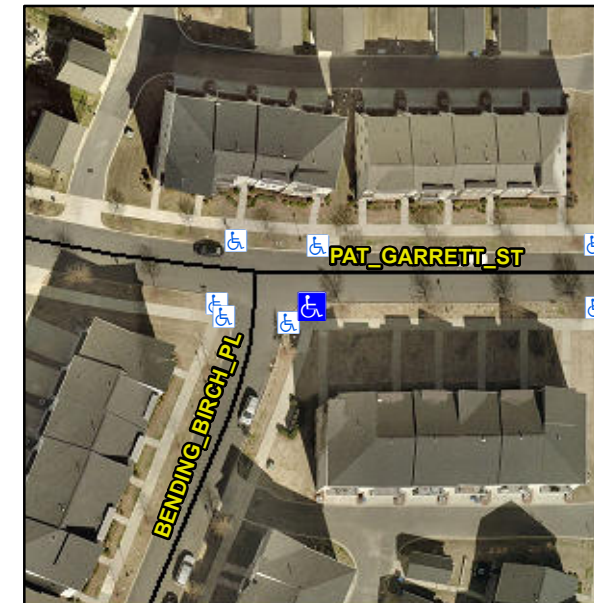
**HOLE IN GTR**

**R304.2.2, R304.5.3**

Compliance	Description	Data	Compliance	Description	Data
N/A	Ramp Length (in)	96.0	N/A	Grade Break?	N/A
Yes	Ramp Width (in)	64.0	N/A	Grade Break Slope (%)	0.0
No	Ramp Slope (%)	11.7	N/A	Grade Break XSlope (%)	0.0
No	Ramp XSlope (%)	5.5			
N/A	Flare Type LT	N/A	N/A	Flare Type RT	N/A
N/A	Flare Slope LT (%)	N/A	N/A	Flare Slope RT (%)	0.0
N/A	Flare Traversable LT?	N/A	N/A	Flare Traversable RT?	N/A
N/A	Landing Length (in)	0.0	N/A	DWS Provided?	N/A
N/A	Landing Width (in)	0.0	N/A	DWS Contrast?	N/A
N/A	Landing Slope (%)	0.0	N/A	DWS Length (in)	N/A
N/A	Landing X Slope (%)	0.0	N/A	DWS Full Width?	N/A
N/A	Landing Curb? (Y/N)	N/A	N/A	DWS Offset LT (in)	N/A
N/A	Shared Landing?	N/A	N/A	DWS Offset RT (in)	N/A
N/A	Gutter Ponding?	0.0	N/A	Gutter Slope (%)	N/A
N/A	Gutter Lip Ht (in)	3.0	N/A	Gutter X Slope (%)	N/A
N/A	Painted X Walk1?	No		Road Slope (%)	9.6
	X Walk 1 Direction	To N		Road X Slope (%)	1.3
	X Walk 1 Width (in)	N/A		Clear Space?	N/A

X Walk 1 Slope (%)	9.6	N/A	Clear Space to XWalk (in)	N/A
	X Walk 1 X Slope (%)	1.3	N/A	Storm Grate/Utility Hazard?	N/A
N/A	Ramp inside XWalk1?	N/A		Storm Grate/Utility Type	
N/A	Any Obstructions?	N/A			N/A
	Obstruction Type		Yes	Surface Condition? (G/P)	Good
			N/A	Curb Slope (%)	1.8

**Remove & Replace Entire Ramp.**
