# Access Compliance Report

## Public Rights-of-Way

### (Curb Ramps)

Intersection ID: 44000	Main Street: ELROSE_PL	Cross Street: GANDER_DR	Location: NW
ADA ID: 8A4A44AC50D0	Ramp Type: Perp	Initial Pass/Fail: Fail	Overall Compliance: No
Codes/Mitigation Info/Possible Solution		Field Measurements/Component Compliance

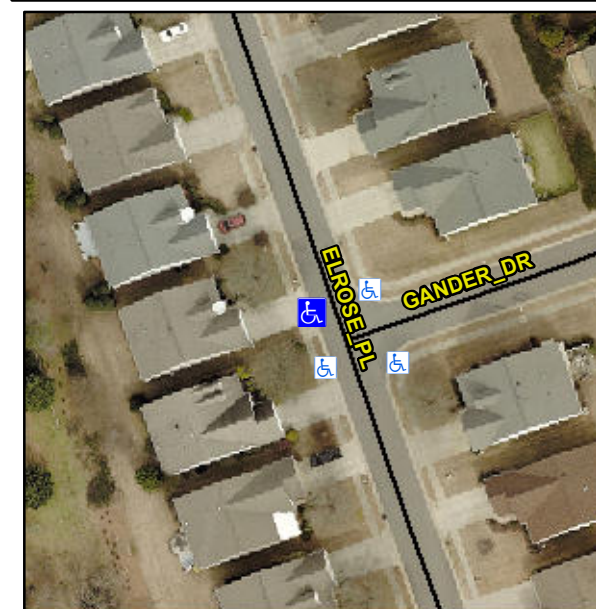
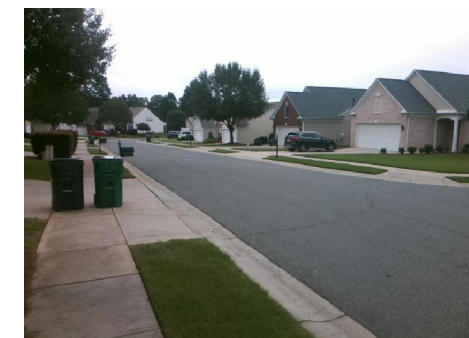
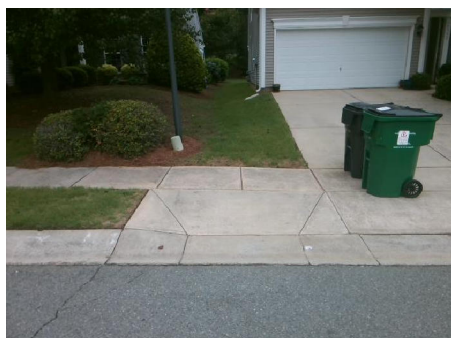
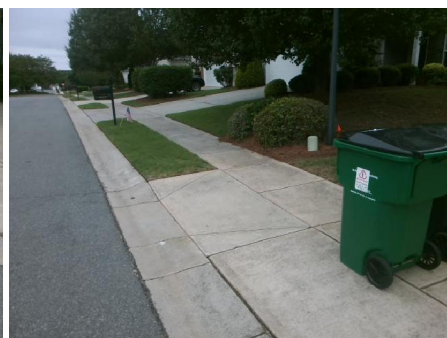
**Not Found, R304.2.2, R304.5.3**

Compliance	Description	Data	Compliance	Description	Data
N/A	Ramp Length (in)	48.0	No	Ramp Slope (%)	11.1
Yes	Ramp Width (in)	48.0	No	Ramp XSlope (%)	5.3
N/A	Flare Type LT	N/A	N/A	Flare Type RT	N/A
N/A	Flare Slope LT (%)	N/A	N/A	Flare Slope RT (%)	N/A
N/A	Flare Traversable LT?	N/A	N/A	Flare Traversable RT?	N/A
N/A	Landing Length (in)	N/A	N/A	DWS Provided?	N/A
N/A	Landing Width (in)	N/A	N/A	DWS Contrast?	N/A
N/A	Landing Slope (%)	N/A	N/A	DWS Length (in)	N/A
N/A	Landing X Slope (%)	N/A	N/A	DWS Full Width?	N/A
N/A	Landing Curb? (Y/N)	N/A	N/A	DWS Offset (in)	N/A
N/A	Shared Landing?	N/A			
N/A	Gutter Ponding?	N/A	N/A	Gutter Slope (%)	N/A
N/A	Gutter Lip Ht (in)	N/A	N/A	Gutter X Slope (%)	N/A
N/A	Painted X Walk1?	No	N/A	Painted X Walk2?	N/A
	X Walk 1 Direction	To E		X Walk 2 Direction	N/A
N/A	X Walk 1 Width (in)	N/A	N/A	X Walk 2 Width (in)	N/A
	X Walk 1 Slope (%)	4.0		X Walk 2 Slope (%)	N/A
	X Walk 1 X Slope (%)	2.6		X Walk 2 X Slope (%)	N/A

N/A	Ramp inside XWalk1?	N/A	N/A	Ramp inside XWalk2?	N/A
	Road Slope (%)	N/A	N/A	Clear Space?	N/A
	Road X Slope (%)	N/A	N/A	Clear Space to XWalk (in)	N/A
N/A	Any Obstructions?	N/A	N/A	Storm Grate/Utility Hazard?	N/A
	Obstruction Type			Storm Grate/Utility Type	
		N/A			N/A
			Yes	Surface Condition? (G/P)	Good

Possible Solutions:

**Remove & Replace Entire Ramp.**
