Access Compliance Report

Public Rights-of-Way

(Curb Ramps)

| Intersection ID: 10034961 | Main Street: PROVIDENCE_RD_WEST | Cross Street: N/A | Location: SW |

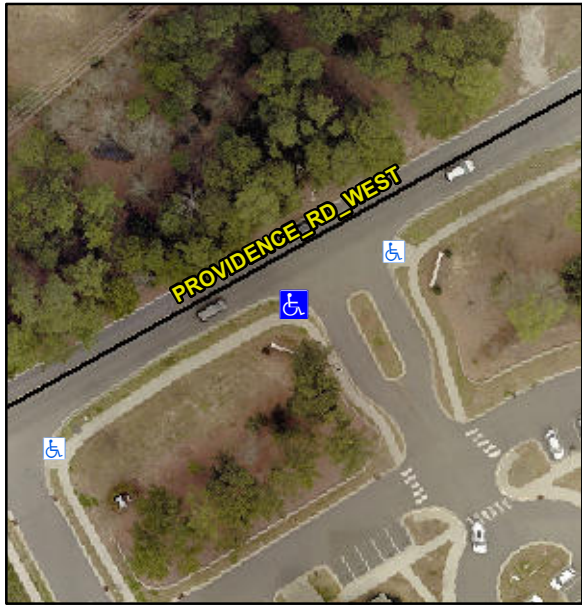
| ADA ID: 8A54203E2761 | Ramp Type: PerpDiag | Initial Pass/Fail: Fail | Overall Compliance: No |

| | PROW/ADA: | | R304.5.1, R304.2.2 | | | |

| Compliance | Description | Data | Compliance | Description | Data |
|---|---|---|---|---|---|
| N/A | Ramp Length (in) | 53.0 | No | Ramp Slope (%) | 9.7 |
| No | Ramp Width (in) | 47.0 | Yes | Ramp XSlope (%) | 0.1 |

| | Possible Solutions: | | Remove & Replace Curb Ramp With Two New Directional Ramps or Equivalent. | | | |
