Intersection ID: 8141	Main Street: CROSSRIDGE_RD	Cross Street: RUNNING_DEER_RD	Location:	W
ADA ID: 8A6F676B9C09	Ramp Type: Perp	Initial Pass/Fail: Fail	Overall Compliance: No	Severity Score: 10

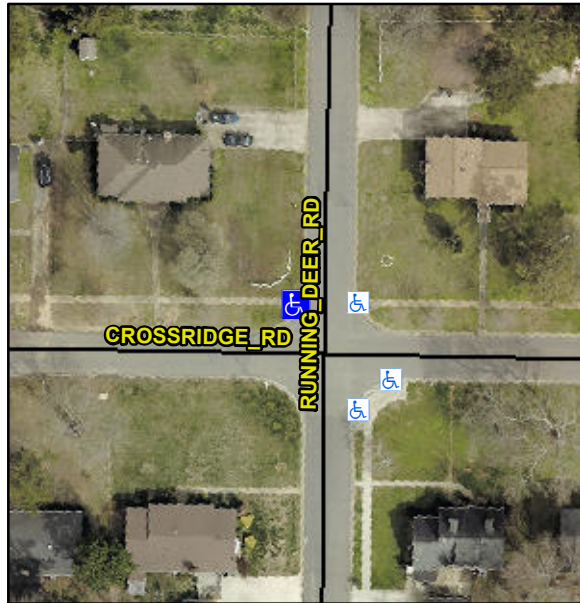
Not Found, R304.5.1, R304.5.3

Compliance	Description	Data	Compliance	Description	Data
N/A	Ramp Length (in)	106.0	Yes	Ramp Slope (%)	5.2
No	Ramp Width (in)	46.0	No	Ramp XSlope (%)	3.9
N/A	Flare Type LT	N/A	N/A	Flare Type RT	N/A
N/A	Flare Slope LT (%)	N/A	N/A	Flare Slope RT (%)	N/A
N/A	Flare Traversable LT?	N/A	N/A	Flare Traversable RT?	N/A
N/A	Landing Length (in)	N/A	N/A	DWS Provided?	N/A
N/A	Landing Width (in)	N/A	N/A	DWS Contrast?	N/A
N/A	Landing Slope (%)	N/A	N/A	DWS Length (in)	N/A
N/A	Landing X Slope (%)	N/A	N/A	DWS Full Width?	N/A
N/A	Landing Curb? (Y/N)	N/A	N/A	DWS Offset (in)	N/A
N/A	Shared Landing?	N/A			
N/A	Gutter Ponding?	N/A	N/A	Gutter Slope (%)	N/A
N/A	Gutter Lip Ht (in)	N/A	N/A	Gutter X Slope (%)	N/A
N/A	Painted X Walk1?	No	N/A	Painted X Walk2?	N/A
	X Walk 1 Direction	To E		X Walk 2 Direction	N/A
N/A	X Walk 1 Width (in)	N/A	N/A	X Walk 2 Width (in)	N/A
	X Walk 1 Slope (%)	6.2		X Walk 2 Slope (%)	N/A
	X Walk 1 X Slope (%)	3.0		X Walk 2 X Slope (%)	N/A

N/A	Ramp inside XWalk1?	N/A	N/A	Ramp inside XWalk2?	N/A
	Road Slope (%)	N/A	N/A	Clear Space?	N/A
	Road X Slope (%)	N/A	N/A	Clear Space to XWalk (in)	N/A
N/A	Any Obstructions?	N/A	N/A	Storm Grate/Utility Hazard?	N/A
	Obstruction Type			Storm Grate/Utility Type	
		N/A			N/A
			Yes	Surface Condition? (G/P)	Good

Remove & Replace Entire Ramp.
