Intersection ID: 14668	Main Street: BARRINGER_DR	Cross Street: MANCHESTER_DR	Location:	NW
ADA ID: 8A7445322D55	Ramp Type: ParaDiag	Initial Pass/Fail: Fail	Overall Compliance: No	Severity Score: 13.75

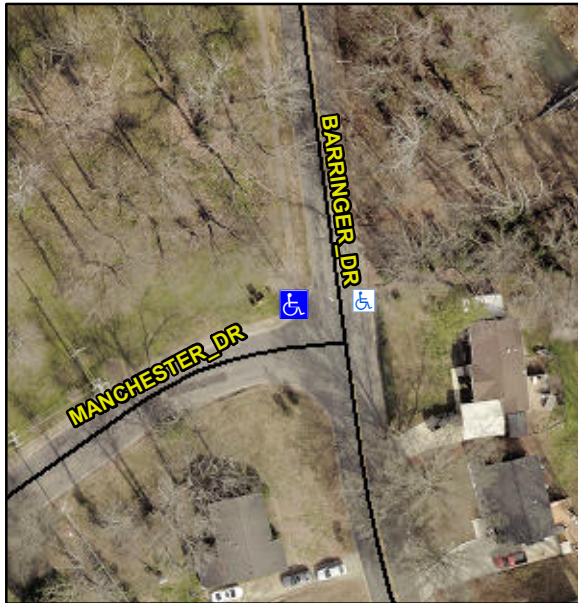
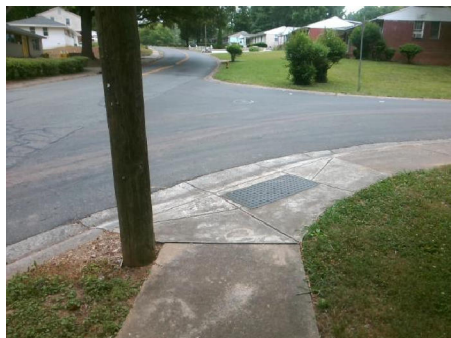
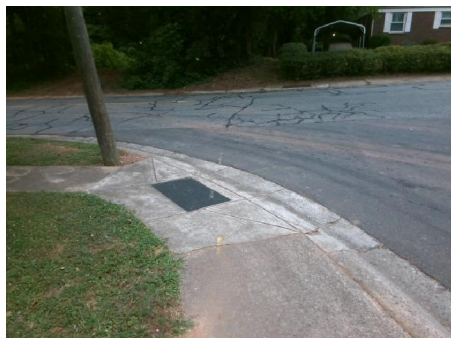
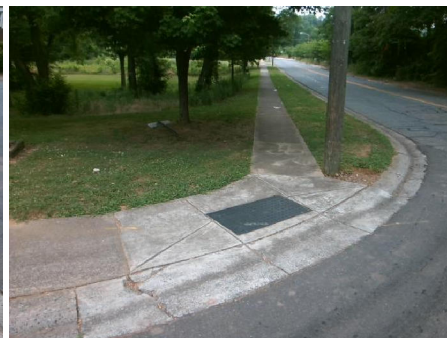
## NO RT RAMP

**R304.3.2, R304.5.3**

Compliance	Description	Data	Compliance	Description	Data
N/A	Ramp Length LT (in)	35.0	N/A	Ramp Length RT (in)	N/A
Yes	Ramp Width LT (in)	48.0	N/A	Ramp Width RT (in)	N/A
No	Ramp Slope LT (%)	9.9	N/A	Ramp Slope RT (%)	N/A
No	Ramp XSlope LT (%)	2.3	N/A	Ramp XSlope RT (%)	N/A
N/A	Landing Length (in)	N/A	N/A	DWS Provided?	N/A
N/A	Landing Width (in)	N/A	N/A	DWS Contrast?	N/A
N/A	Landing Slope (%)	N/A	N/A	DWS Length (in)	N/A
N/A	Landing X Slope (%)	N/A	N/A	DWS Full Width?	N/A
N/A	Landing Curb? (Y/N)	N/A	N/A	DWS Offset (in)	N/A
N/A	Shared Landing?	N/A			
N/A	Gutter Ponding?	N/A	N/A	Gutter Slope (%)	N/A
N/A	Gutter Lip Ht (in)	N/A	N/A	Gutter X Slope (%)	N/A
N/A	Painted X Walk1?	No	N/A	Painted X Walk2?	No
	X Walk 1 Direction	To S		X Walk 2 Direction	To W
N/A	X Walk 1 Width (in)	N/A	N/A	X Walk 2 Width (in)	N/A
	X Walk 1 Slope (%)	9.8		X Walk 2 Slope (%)	2.2
	X Walk 1 X Slope (%)	1.3		X Walk 2 X Slope (%)	9.4
N/A	Ramp inside XWalk1?	N/A	N/A	Ramp inside XWalk2?	N/A

Road Slope (%)	3.9	N/A	Clear Space?	N/A
	Road X Slope (%)	9.9	N/A	Clear Space to XWalk (in)	N/A
N/A	Any Obstructions?	N/A	N/A	Storm Grate/Utility Hazard?	N/A
	Obstruction Type			Storm Grate/Utility Type	
		N/A			N/A
			Yes	Surface Condition? (G/P)	Good
			N/A	Curb Slope (%)	3.7

**Remove & Replace Curb Ramp With Two New Directional Ramps or Equivalent.**
