Access Compliance Report

Public Rights-of-Way

(Curb Ramps)

Intersection ID: N/A	Main Street: ROMARE_BEARDEN_DR	Cross Street: FARMER_ST	Location: SE
ADA ID: 8A7B7F385EB0	Ramp Type: PerpDiag	Initial Pass/Fail: Fail	Overall Compliance: No
		Severity Score: 10

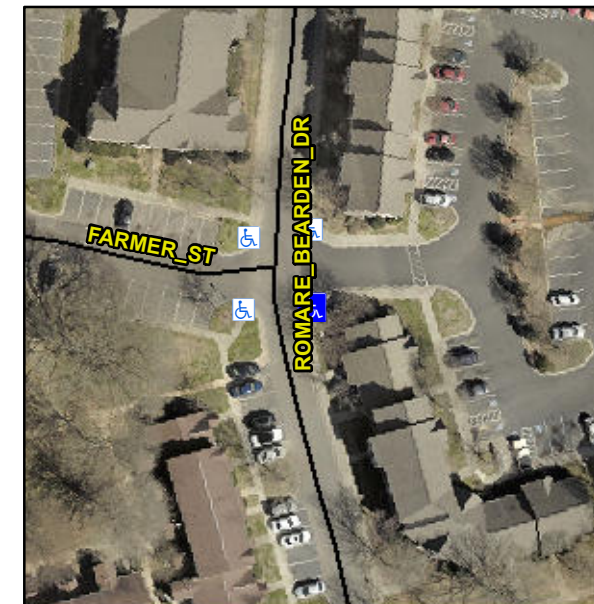
Compliance	Description	Data	Compliance	Description	Data
N/A	Ramp Length (in)	60.0	Yes	Ramp Slope (%)	6.8
No	Ramp Width (in)	36.0	No	Ramp XSlope (%)	4.1
N/A	Flare Type LT	N/A	N/A	Flare Type RT	N/A
N/A	Flare Slope LT (%)	N/A	N/A	Flare Slope RT (%)	N/A
N/A	Flare Traversable LT?	N/A	N/A	Flare Traversable RT?	N/A
N/A	Landing Length (in)	N/A	N/A	DWS Provided?	N/A
N/A	Landing Width (in)	N/A	N/A	DWS Contrast?	N/A
N/A	Landing Slope (%)	N/A	N/A	DWS Length (in)	N/A
N/A	Landing X Slope (%)	N/A	N/A	DWS Full Width?	N/A
N/A	Landing Curb? (Y/N)	N/A	N/A	DWS Offset (in)	N/A
N/A	Shared Landing?	N/A			
N/A	Gutter Ponding?	N/A	N/A	Gutter Slope (%)	N/A
N/A	Gutter Lip Ht (in)	N/A	N/A	Gutter X Slope (%)	N/A
N/A	Painted X Walk1?	No	N/A	Painted X Walk2?	No
	X Walk 1 Direction	To N		X Walk 2 Direction	To W
N/A	X Walk 1 Width (in)	N/A	N/A	X Walk 2 Width (in)	N/A
	X Walk 1 Slope (%)	3.6		X Walk 2 Slope (%)	0.8
	X Walk 1 X Slope (%)	4.3		X Walk 2 X Slope (%)	3.2

N/A	Ramp inside XWalk1?	N/A	N/A	Ramp inside XWalk2?	N/A
	Road Slope (%)	1.5	N/A	Clear Space?	N/A
	Road X Slope (%)	5.4	N/A	Clear Space to XWalk (in)	N/A
N/A	Any Obstructions?	N/A	N/A	Storm Grate/Utility Hazard?	N/A
	Obstruction Type			Storm Grate/Utility Type	
		N/A			N/A
		Yes		Surface Condition? (G/P)	Good

Remove & Replace Curb Ramp With Two New Directional Ramps or Equivalent.

R304.5.1, R304.5.3
